### **Randolph Street Intercounty Drain Drainage Board** Wayne and Oakland Counties

**March 3, 2023 – 10:00 a.m.**

**SUBJECT:** Randolph Street Drain & Serenity Point Improvement Project

# RANDOLPH STREET DRAIN

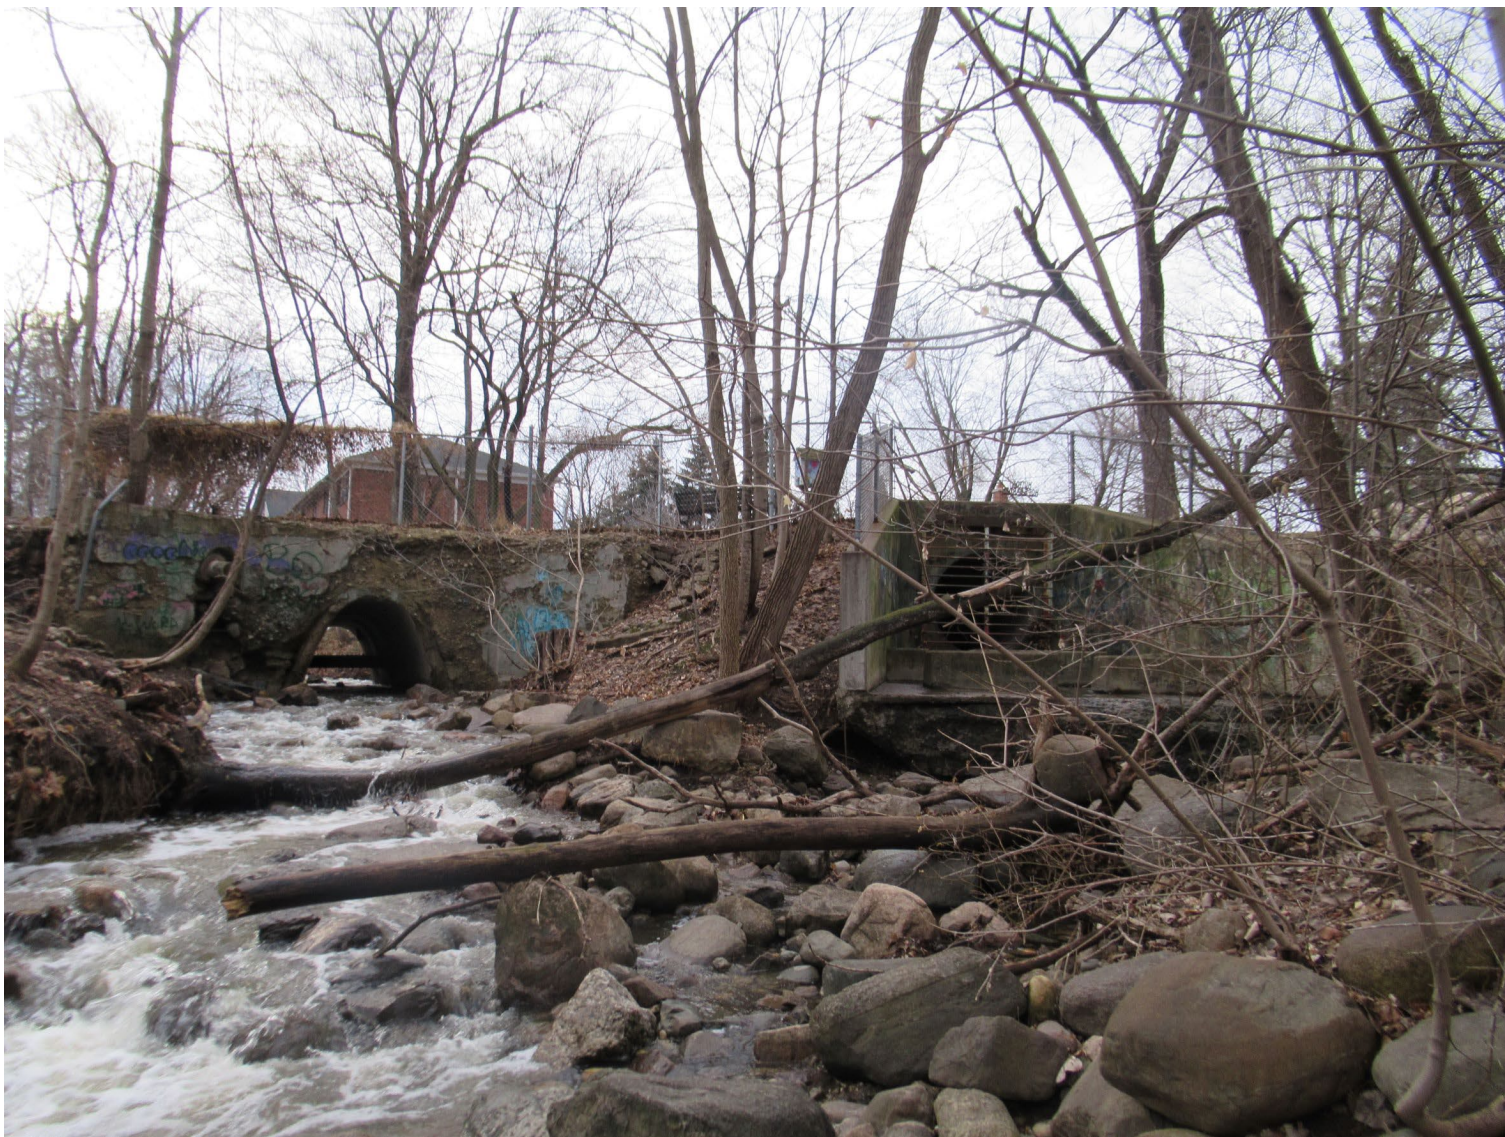
Randolph Street Drain

Downstream terminus, looking upstream toward Hutton Street.

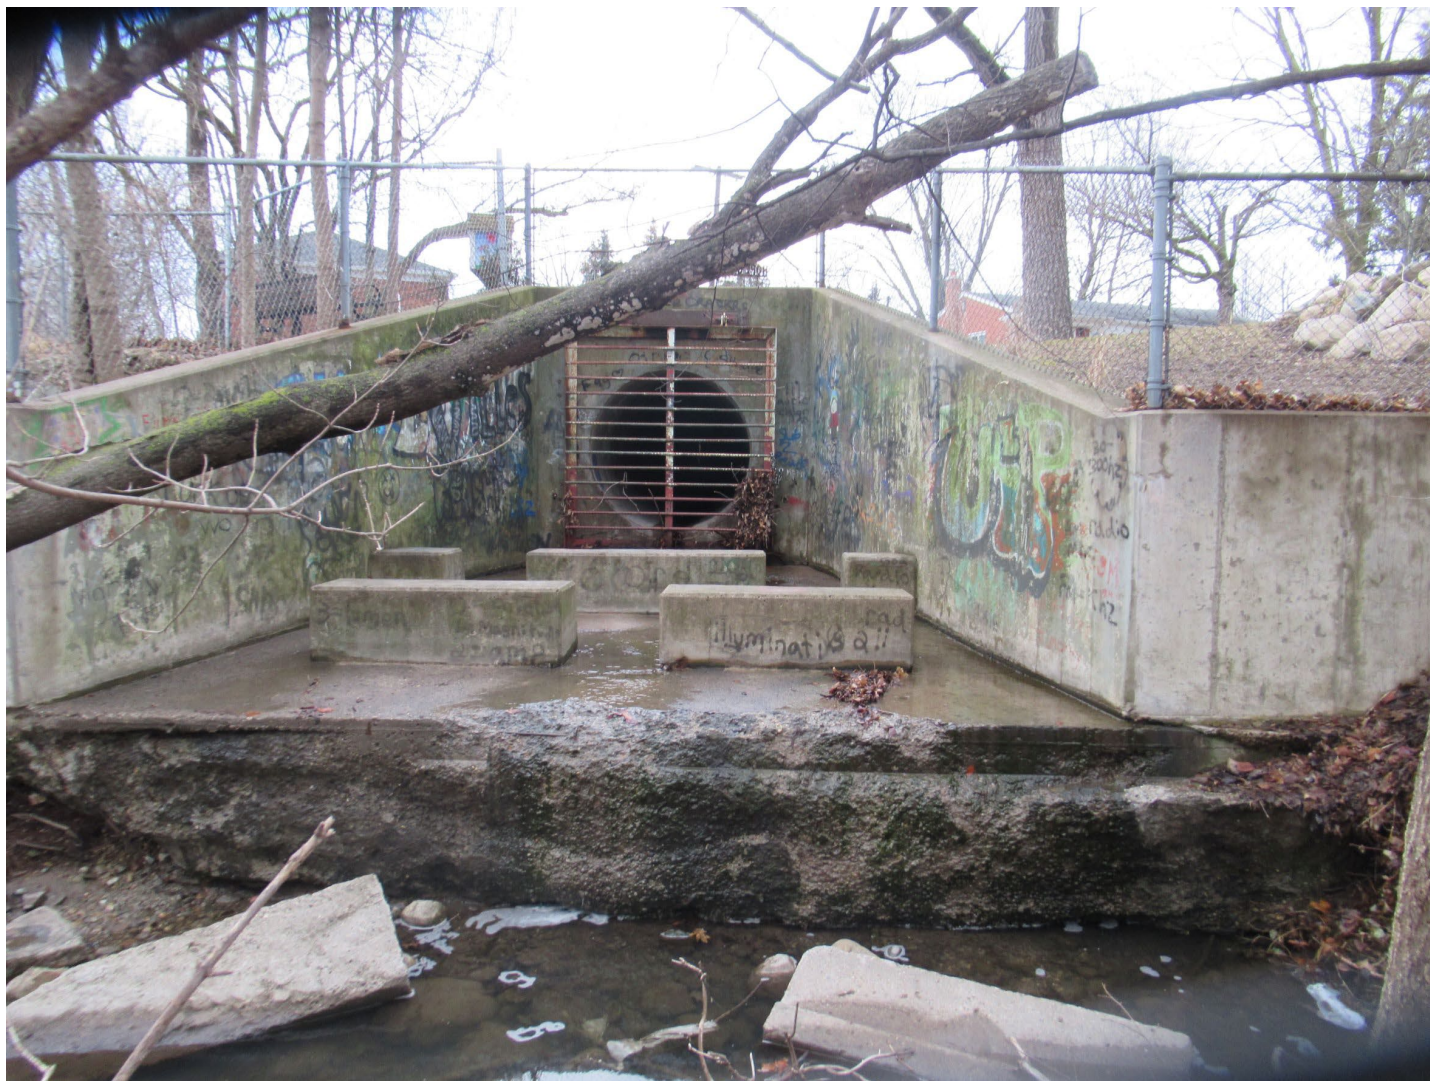
Randolph Street Drain

Enclosed portion outlet downstream of Hutton Street.

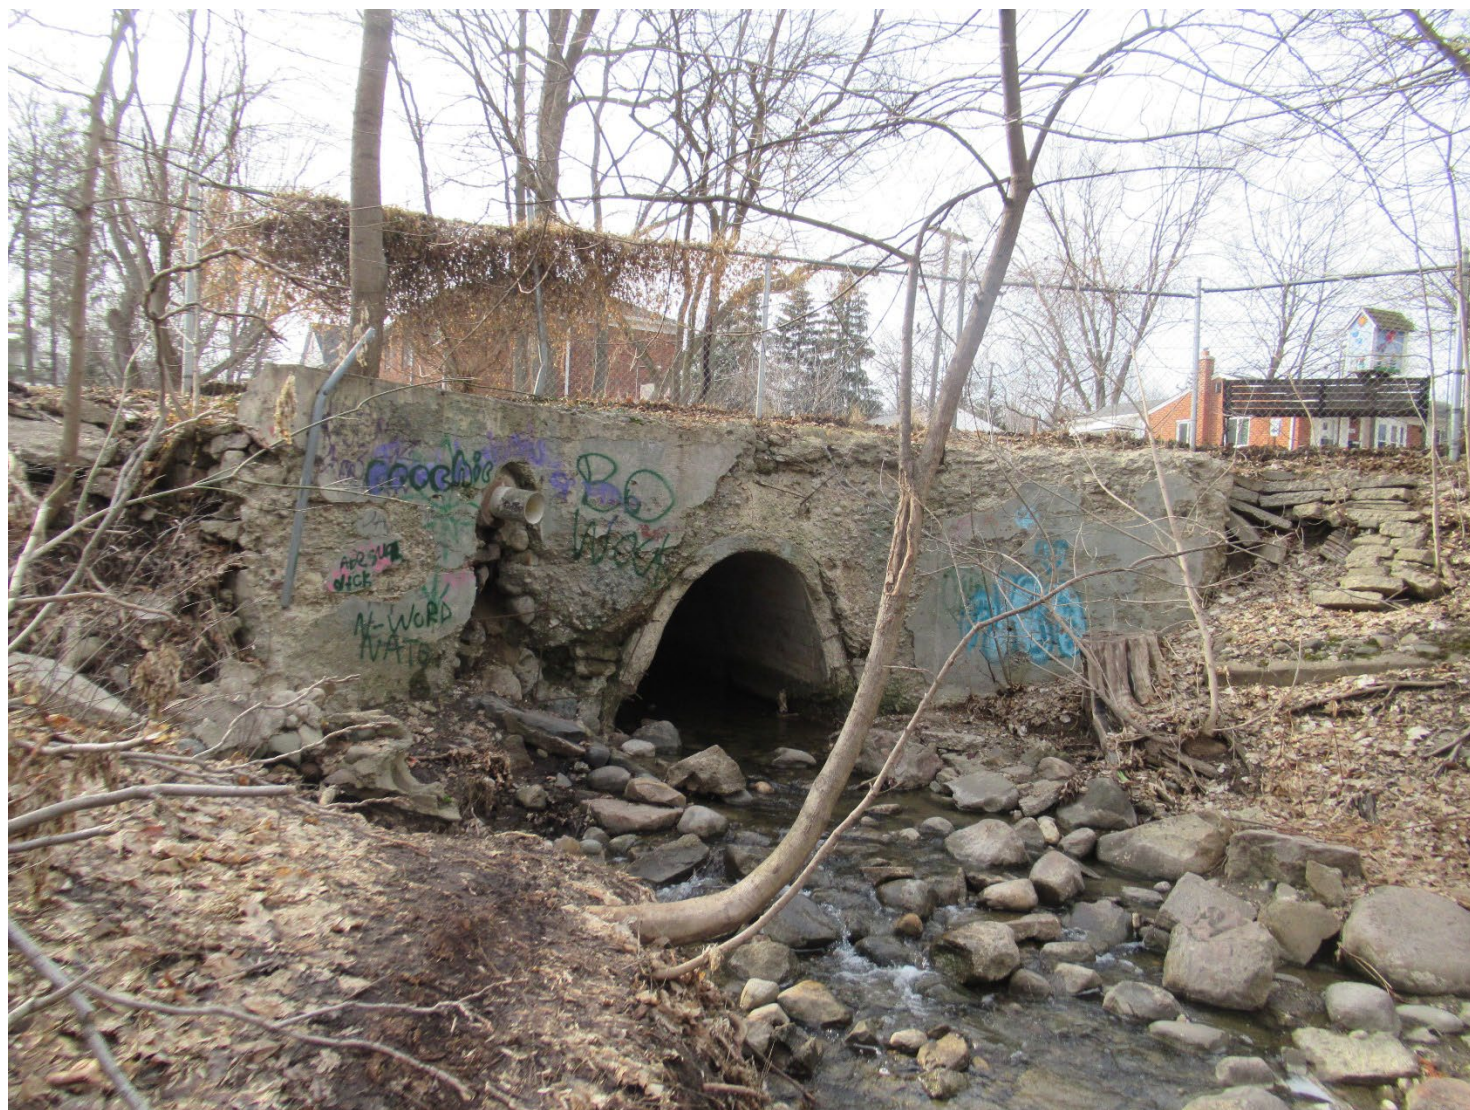
Randolph Street Drain

Hutton Street culvert over low flow channel.

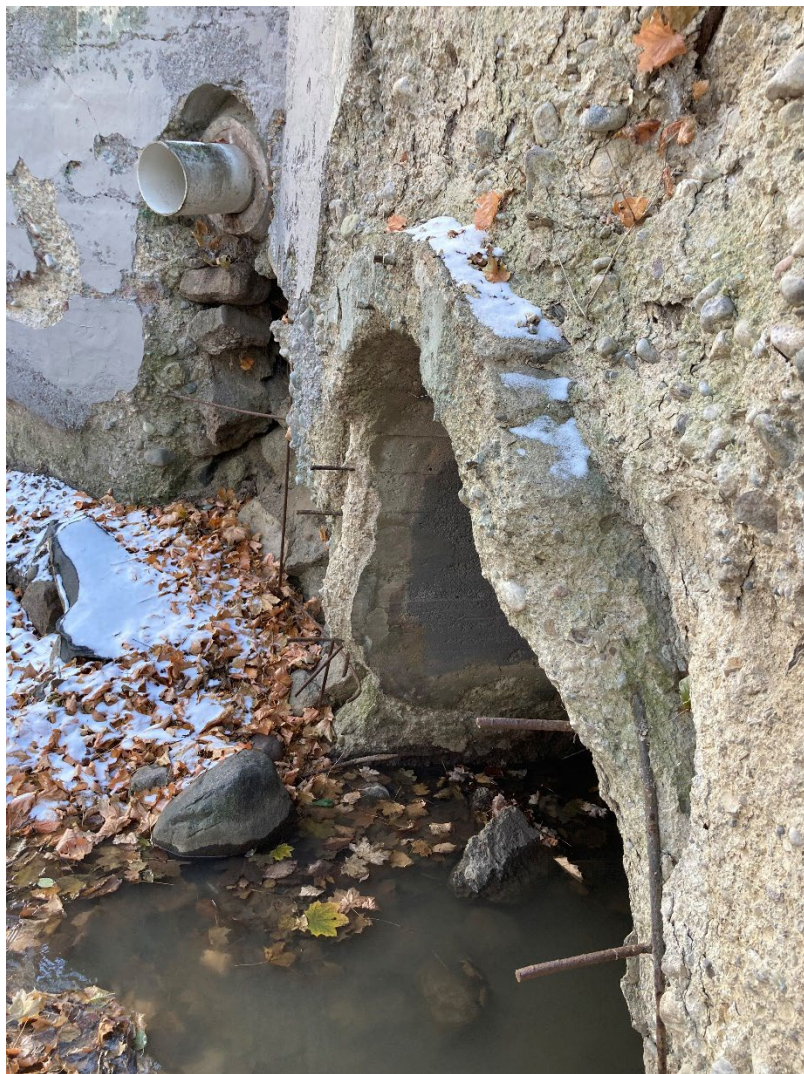
Randolph Street Drain

Hutton Street culvert over low flow channel.

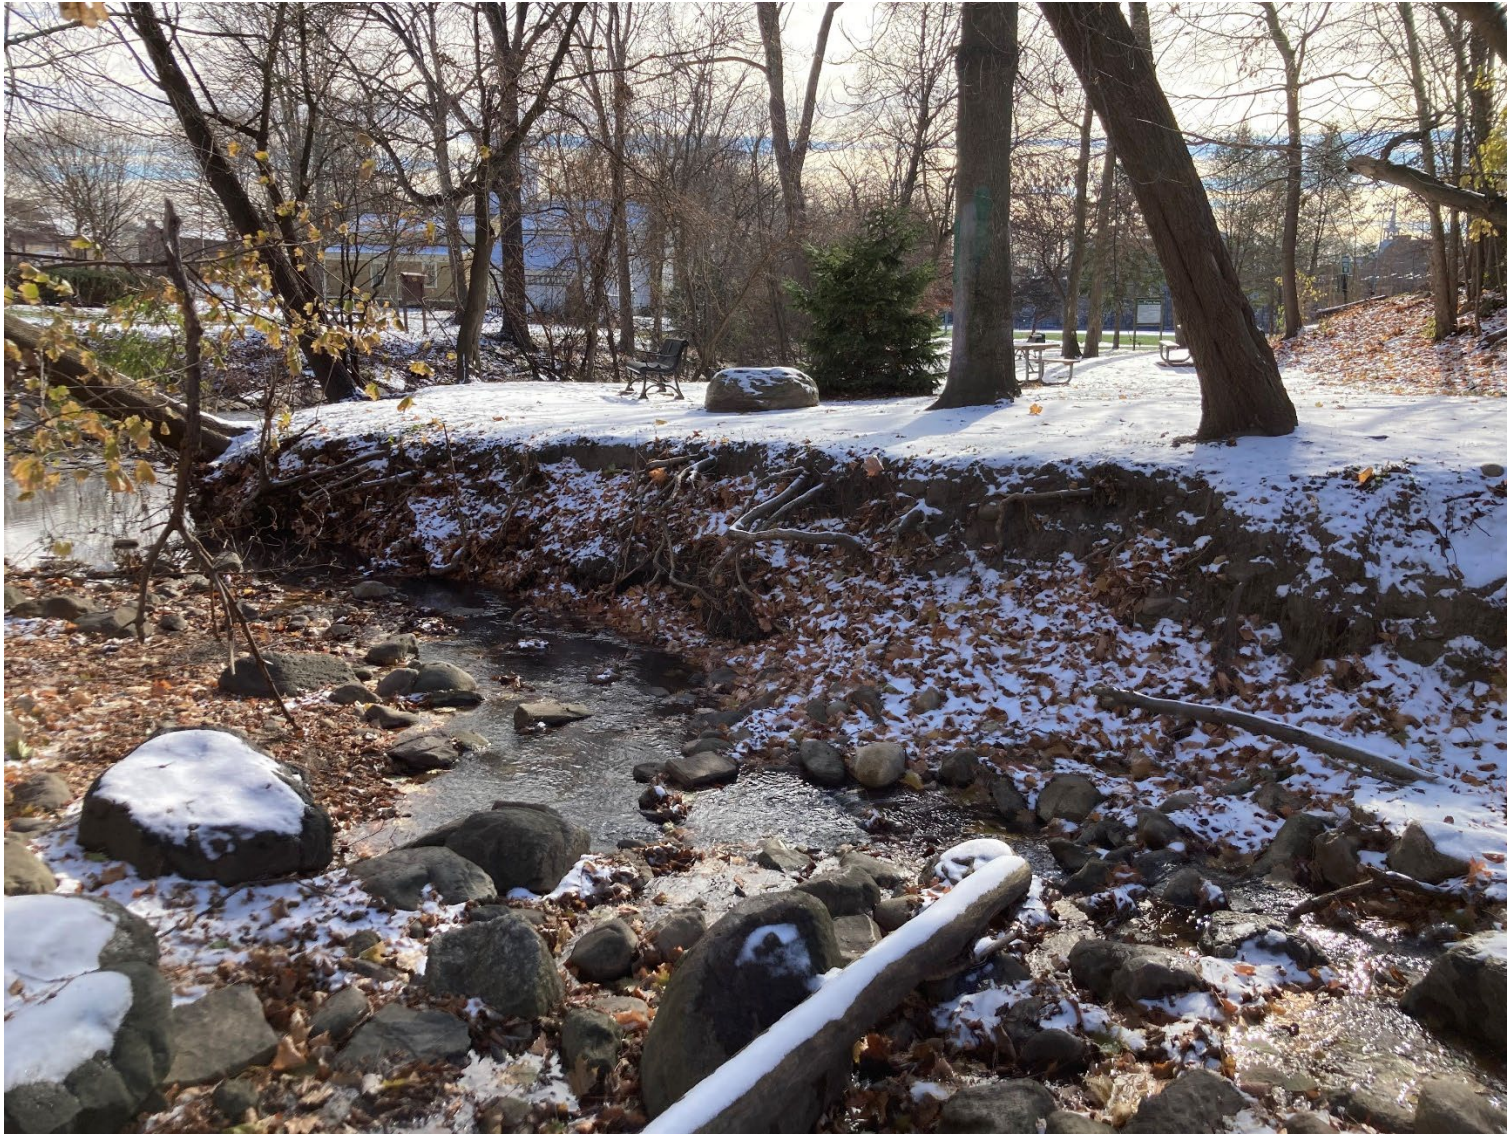
Randolph Street Drain

Outlet of enclosed portion. Looking downstream with Ford Field in the background.

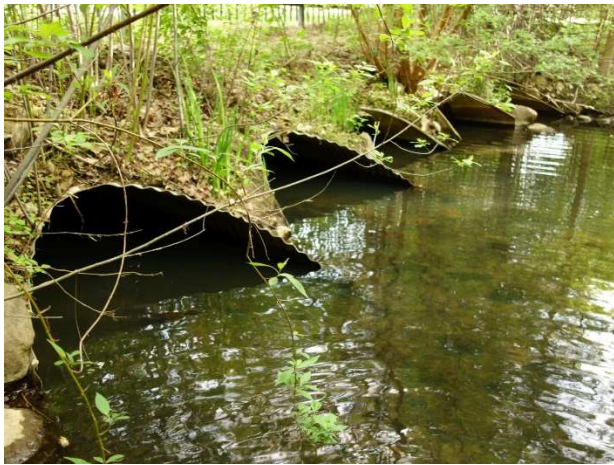
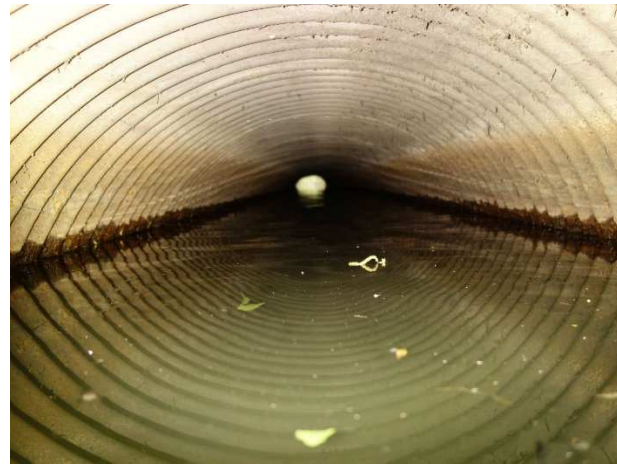
The Coldsprings Drive culvert is a series of 5 adjacent culverts with approximately 2' of separation. The north 3 pipes are 42" span by 30" rise elliptical CMP. The south 2 pipes are 60" span by 38" arch CMP. All pipes are approximately 65' long with 2' of cover. These pipes are in overall fair condition with light scaling throughout each pipe and general light rust along the waterline. However, a full invert inspection was not feasible due to standing water and small pipe size. These culverts serve as wetland equalization pipes and appear to always have standing water. No work is recommended at this time.

Pictures 1 & 2: Coldsprings culvert condition

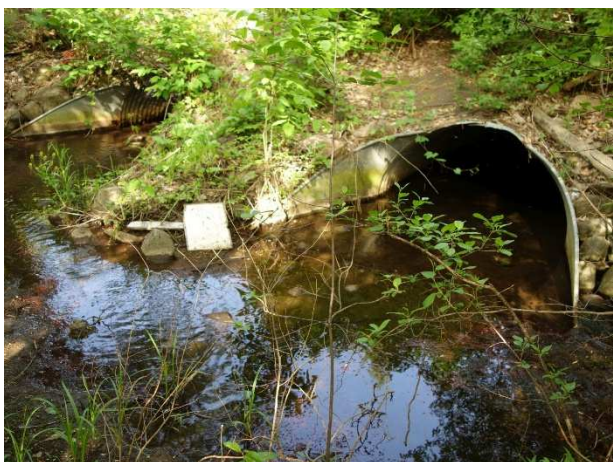
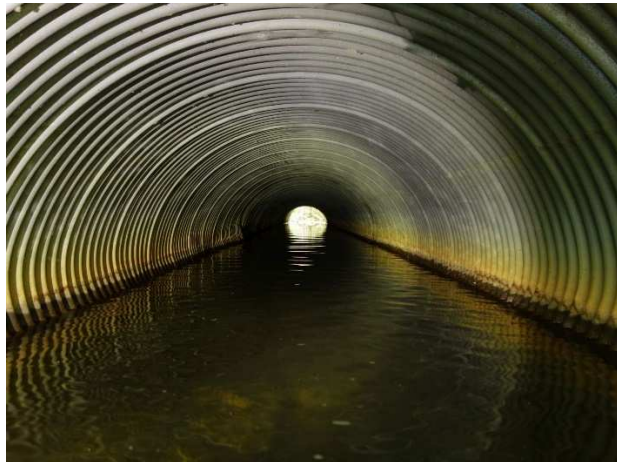
The McDonald Drive culverts are two adjacent 68" span by 45" rise arch CMP with approximately 6' of separation. They are approximately 85' long with 4' of cover and a 60 degree angle of crossing. These pipes are in overall fair condition with light scaling throughout each pipe and general light rust along the waterline. No work is recommended at this time.

Pictures 3 & 4: McDonald culvert condition

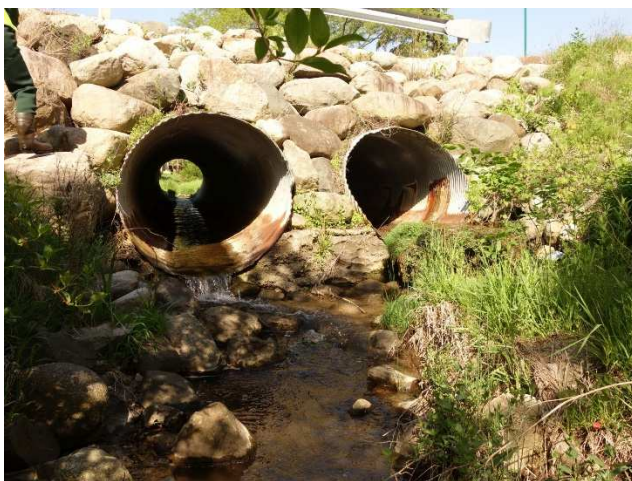
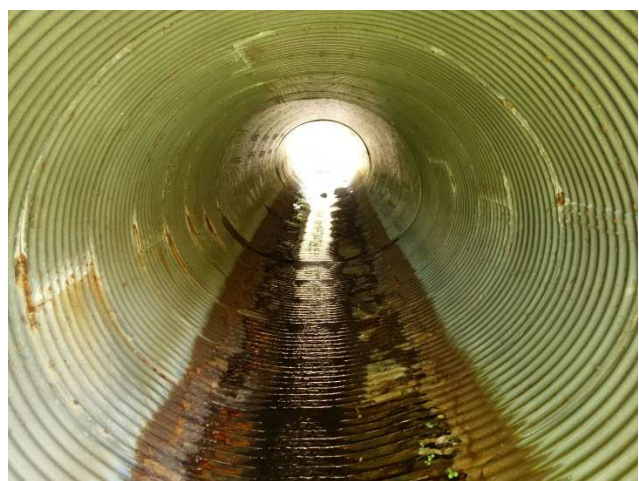
The Lexington Boulevard culverts are two adjacent 75" span by 66" rise arch CMP with approximately 2.5' of separation. They are approximately 63' long with 5' of cover at a 80-degree angle of crossing. The condition of these pipes are poor/serious with isolated heavy scaling in the walls, heavy corrosion throughout the bottom with numerous holes. There is some evidence of loss of bedding material through the holes and little remains of the pipe inverts. The culvert is perched (culvert invert located above the natural stream bed elevation) approximately 1'-1.5' on the downstream end. It is recommended that this crossing be budgeted and scheduled for replacement as soon as possible. Immediate action is recommended to plug the larger holes with grout and place a concrete canvas liner along the bottom and partially up the sidewalls. This work should be completed as soon as possible but no later than the next couple months. The concrete canvas is not a long-term fix but is usually very effective in preventing additional loss of bedding material and protecting the bottom of pipe from peeling during high flow events.

Pictures 5 & 6: Lexington outfall and north pipe condition

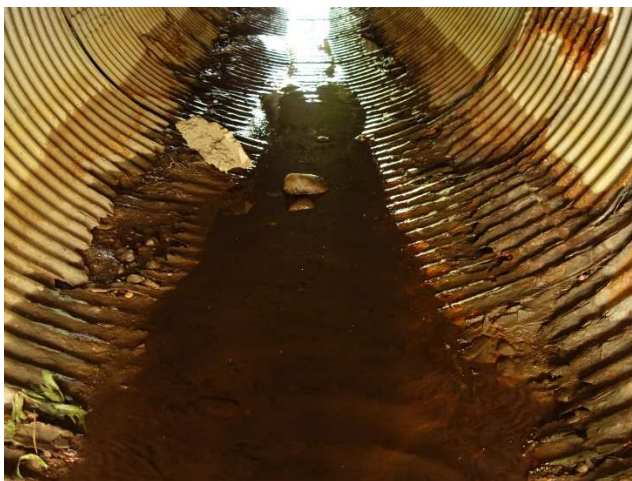
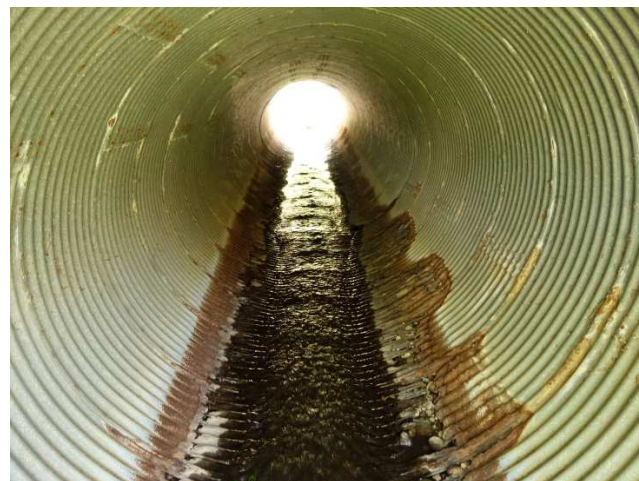
Pictures 7 & 8: Lexington typical invert condition and south pipe condition

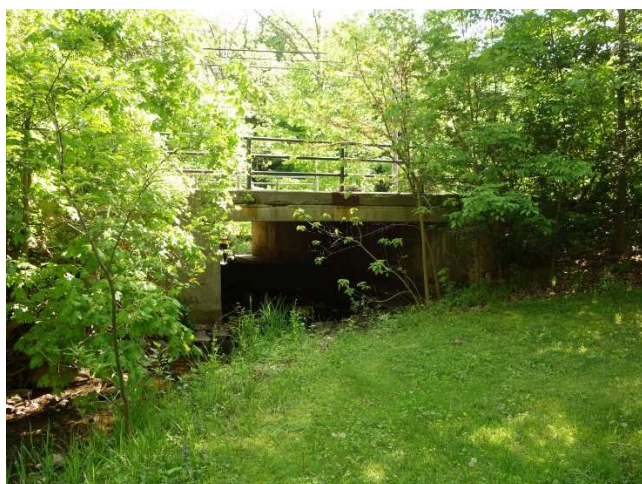
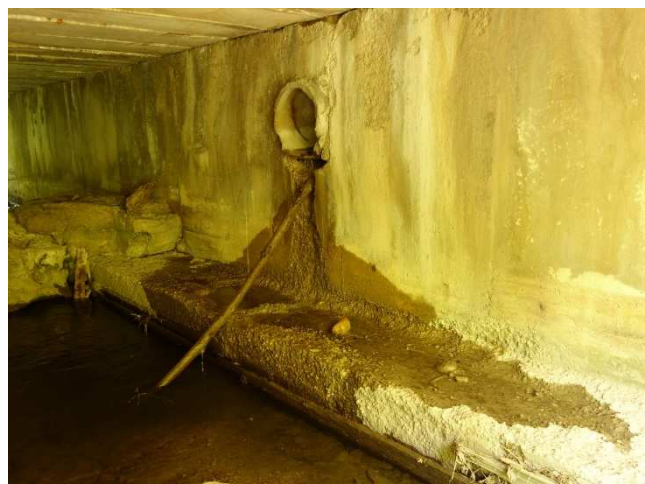
The Randolph Street crossing is a 16' span by 7' rise bridge which is not long enough to be on the MDOT system. The bridge has a clear roadway width of 32' and an overall width of 47'. The crossing is 90 degrees to the road. The superstructure is comprised of twenty-four (24) 12" deep adjacent concrete box beams. This crossing is at a poor alignment to the Randolph drain. The beams are in overall poor condition. The following beams have noteworthy deterioration. Beams 7 through 10 and 12 through 14 have heavy spalling and exposed strands. Beam 8 has 2 broken strands at midspan. The abutments are in overall fair condition with some delamination and scaling throughout. The north abutment has a storm tap through the wall. Both the storm pipe and the abutment wall has scaled in this area. There is a 3' thick concrete encasement of a utility running through the middle of the bridge at the footing level. This encasement has caused the water to flume under it and created a scour hole that has exposed and undermined the bridge footing for the eastern half of the south abutment. It is recommended that a load rating be performed if existing plans are available. It is recommended that this bridge be monitored every 12-24 months and be budgeted for eventual replacement and utilities relocated in approximately 10 years.

Pictures 9 & 10: Randolph west elevation and north abutment

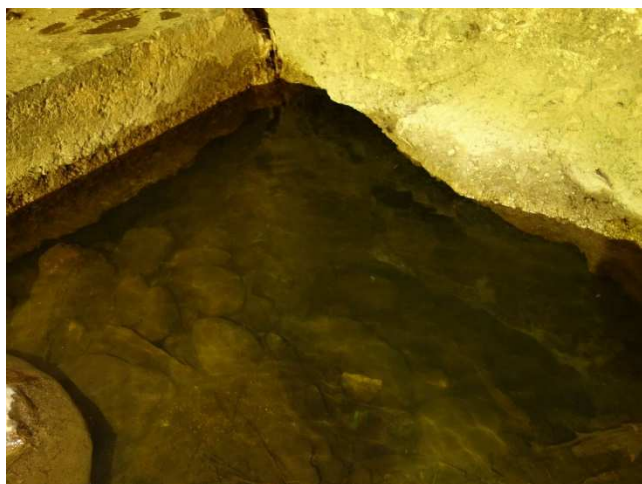
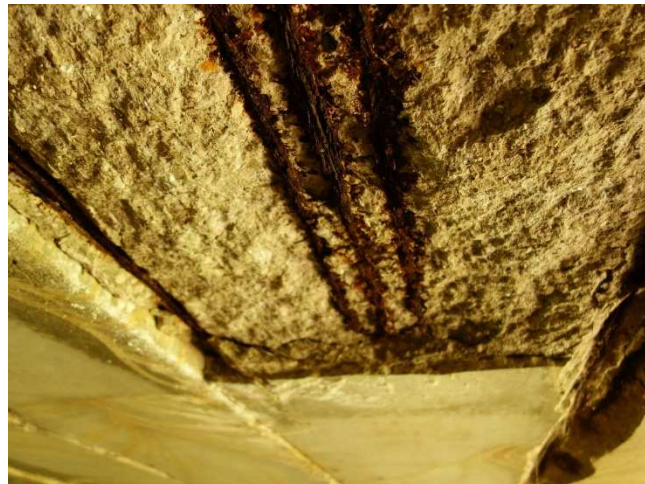
Pictures 11 & 12: Randolph scour hole south abutment and spalling on beams with exposed reinforcement

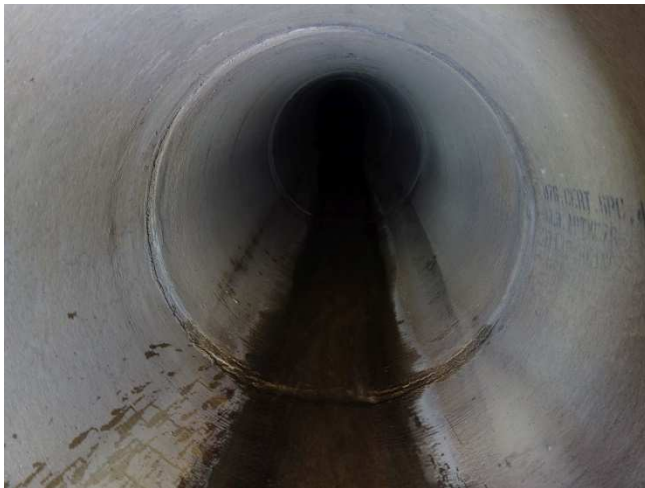
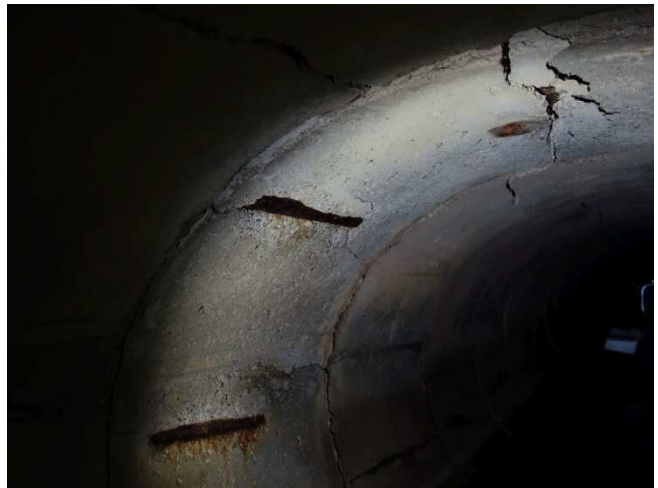
- Section 1: 104' of 42" round class III concrete pipe in good condition.
- Section 2: 53' of 54" round concrete pipe in poor condition with several wide longitudinal cracks up to 1" wide. The pipe appears not to be reinforced.
- Section 3: 27' of 54" concrete pipe in good condition with some minor joint separation.
- Section 4: 8' of 60" concrete pipe in good condition.
- Section 5: 20' of 3-sided brick on stone masonry culvert in poor condition with loss of grout, voids in the masonry and a partially collapsed are with a utility duct running through.
- Section 6: 69' of 4.5' span by 4.5' rise cast-in-place 3-sided concrete box culvert in poor condition with spalling along 50% along the waterline and spalling throughout the top slab.

Pictures 13 & 14: Center sections 1 and 2

The recommended work for this part of the culvert is a full replacement of at least sections 2-6.

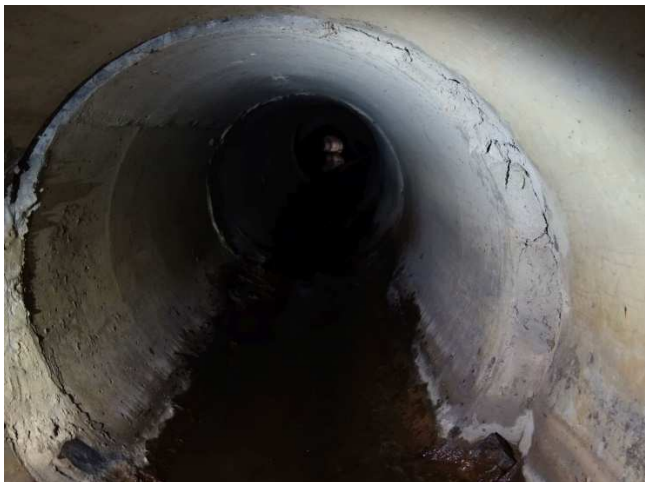
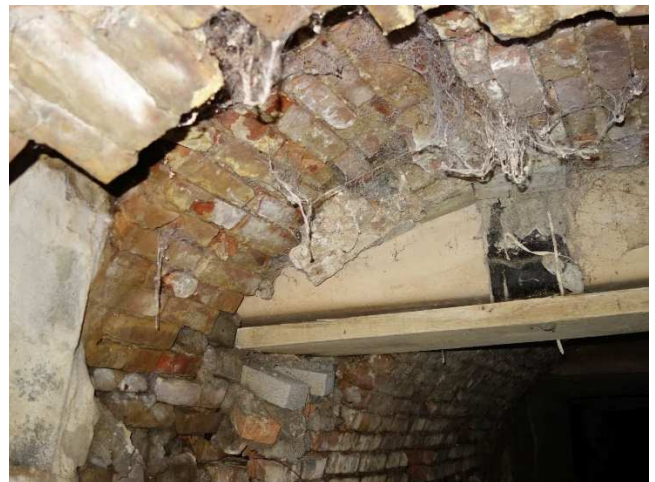
Pictures 15 & 16: Center section (3 and 4) and partial collapse of section 5

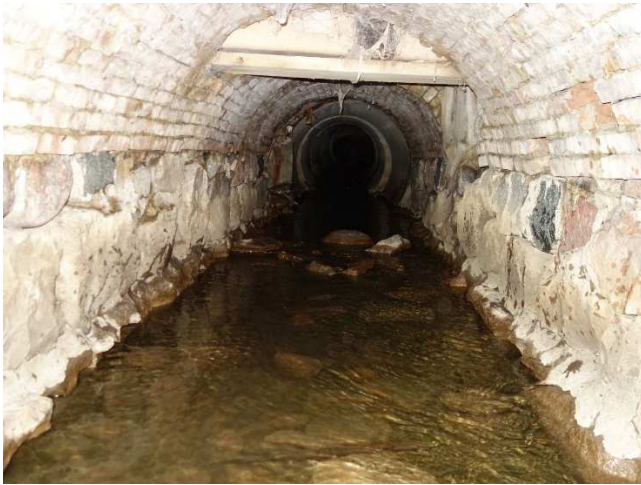
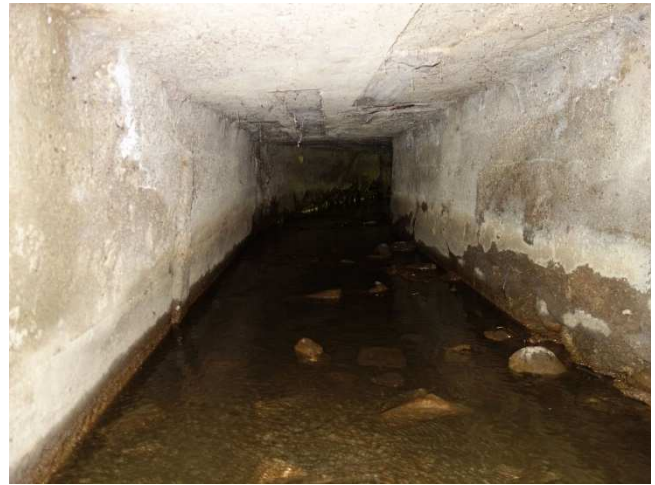
Pictures 17 & 18: Center sections 5 and 6

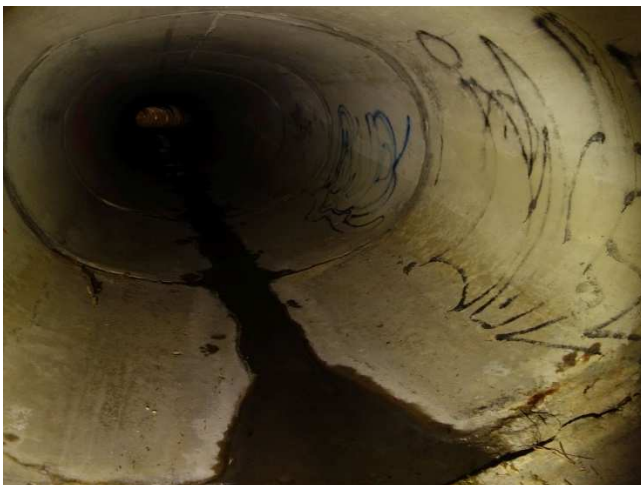
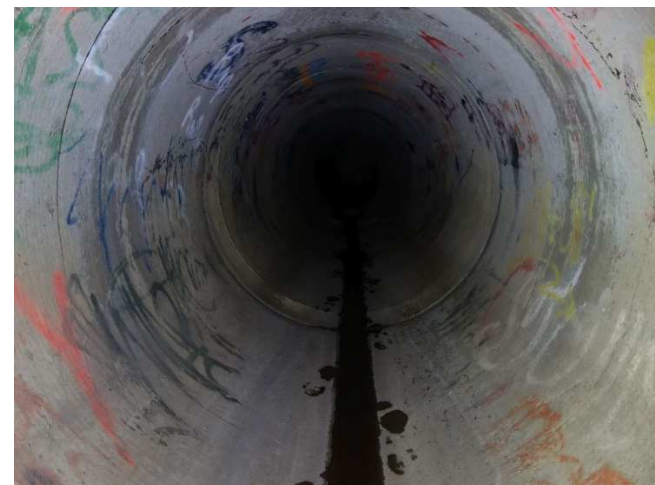
The secondary flow path independent of the main flow path by approximately 2' elevation consists of 6.9' span by 4.4' rise concrete elliptical pipe and 66" round concrete pipe. The path of the pipe meanders throughout 5 separate tangent sections with the ultimate outfall west of Hutton Street at the Rouge River. Both ends are protected by a rebar grate. The pipe is in overall good condition with minor spalling in isolated locations. There are several blind taps into this run of pipe. No work is recommended at this time.

Pictures 19 & 20: Center overflow general pipe condition.

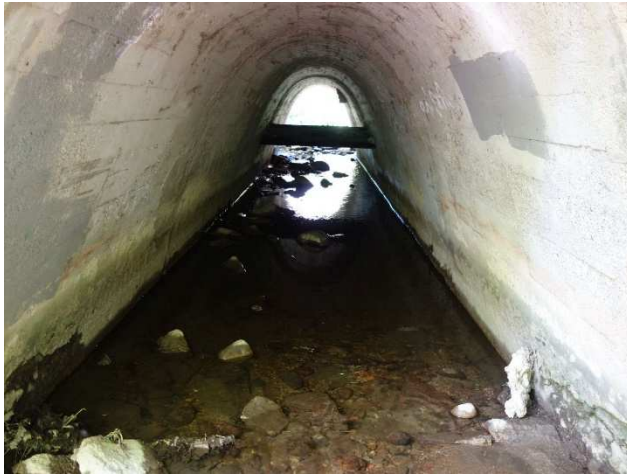
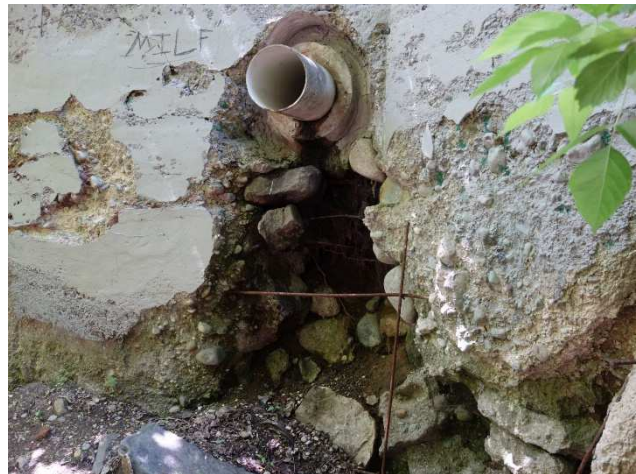
The Hutton Street culvert consists of a 6' span by 7' rise concrete arch with full concrete invert. The culvert is approximately 50' long. The culvert is in overall fair condition with some scaling throughout. There are two 12" utilities running through the middle of culvert. The east and west headwalls and wingwalls are in poor condition with large areas of spalling and deterioration. There is instability at the downstream end outfall. It is recommended that both end treatments be replaced, and the outfall end be stabilized.

Pictures 21 & 22: Hutton general culvert condition and southwest wingwall condition

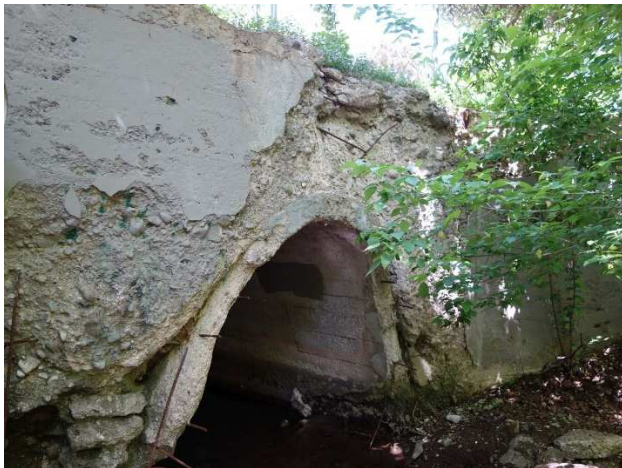
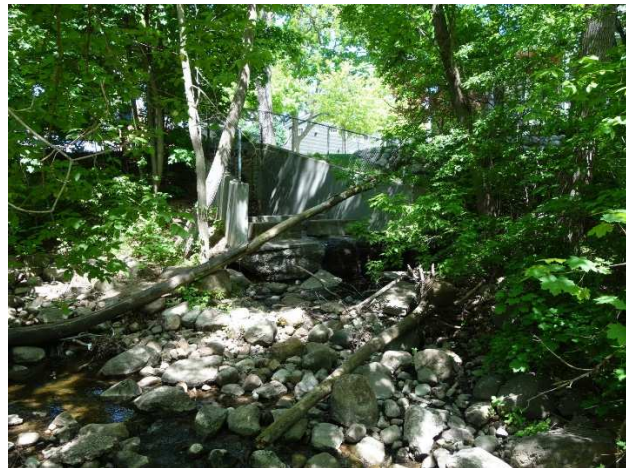
Pictures 23 & 24: Hutton general culvert east end and Center Street overflow pipe outlet at Hutton

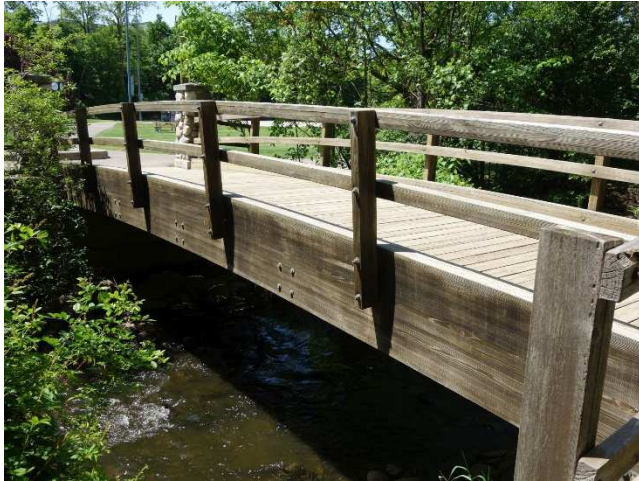
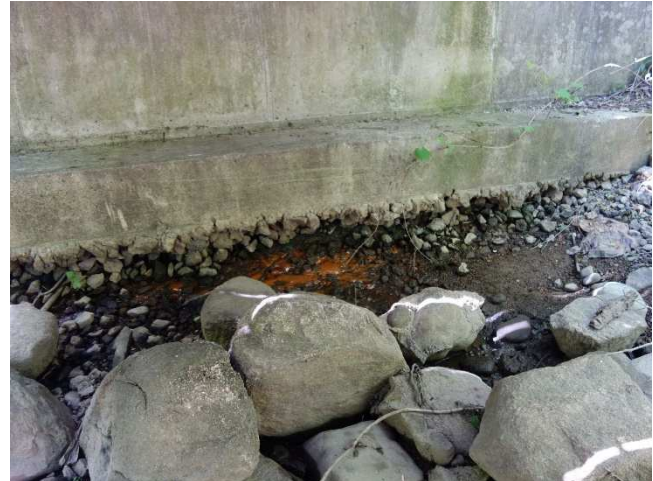
The pedestrian bridge over the Rouge River connecting Ford Field to Mill Race Park is 33.5' span by 9' wide timber structure in fair condition. The wood decking is in overall fair condition with minor dry rot. The abutments are in good condition. The south footing is exposed. It is recommended that the south footing be protected with riprap and the settlement accumulation in the approaches be removed.

Pictures 25 & 26: Rouge Pedestrian Bridge general condition and south abutment erosion

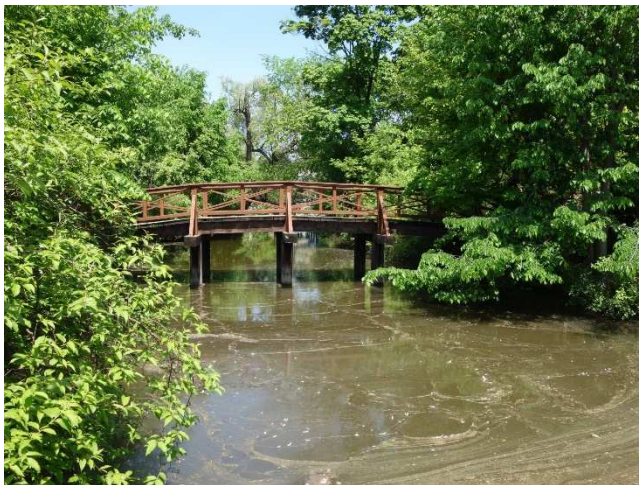
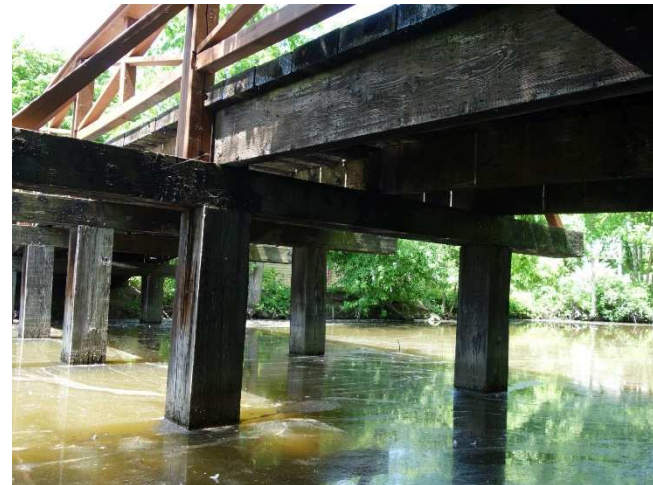
The pedestrian bridge over the mill pond is a multi-span timber structure in overall fair condition. There is some dry rot and general decay of visible the wood elements. The portions of timber piles below water were not inspected due to the water turbidity. The member sizes for this structure are substantial and no work is recommended at this time.

Pictures 27 & 28: Rouge Pedestrian Bridge south elevation and general condition
