CWSRF STORMWATER PROJECT PLAN FOR THE JOACHIM DRAIN DRAINAGE DISTRICT IMPROVEMENTS

FOR OAKLAND COUNTY WATER RESOURCES COMMISSIONER

April 7, 2023
HRC Job No. 20220981

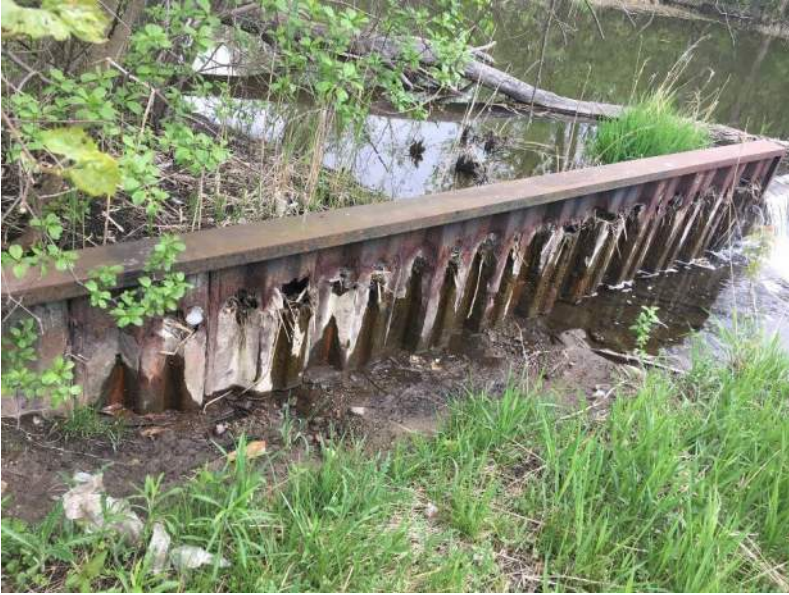
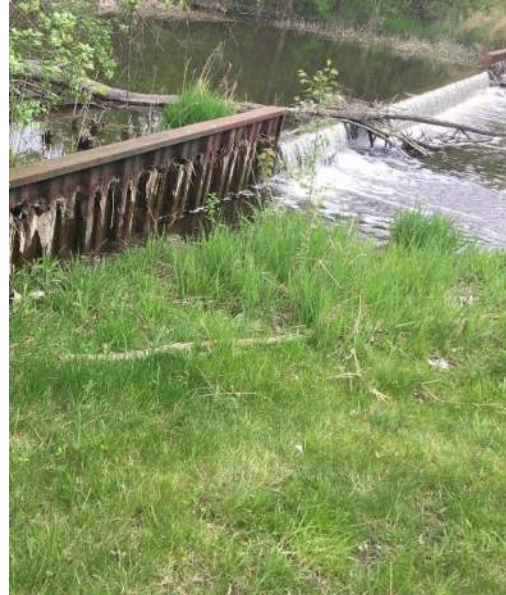
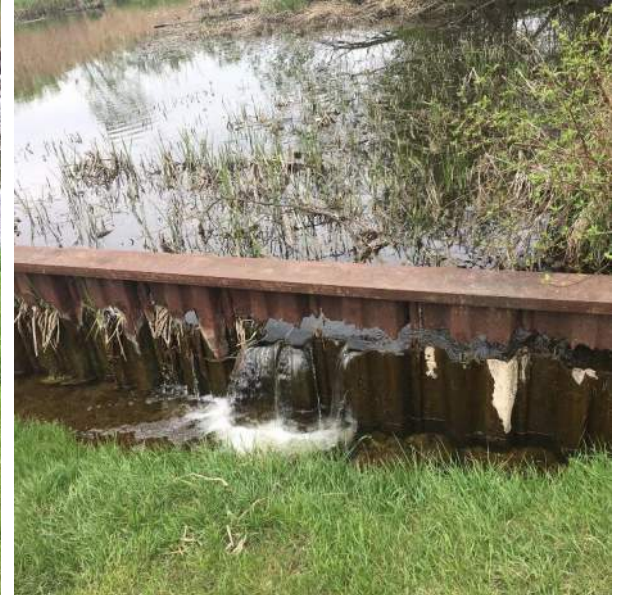
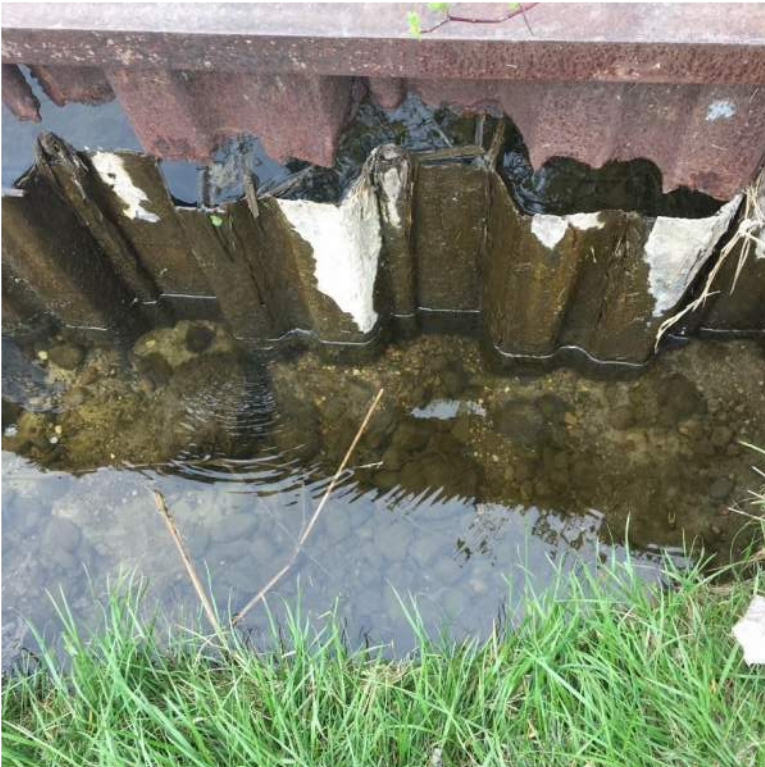
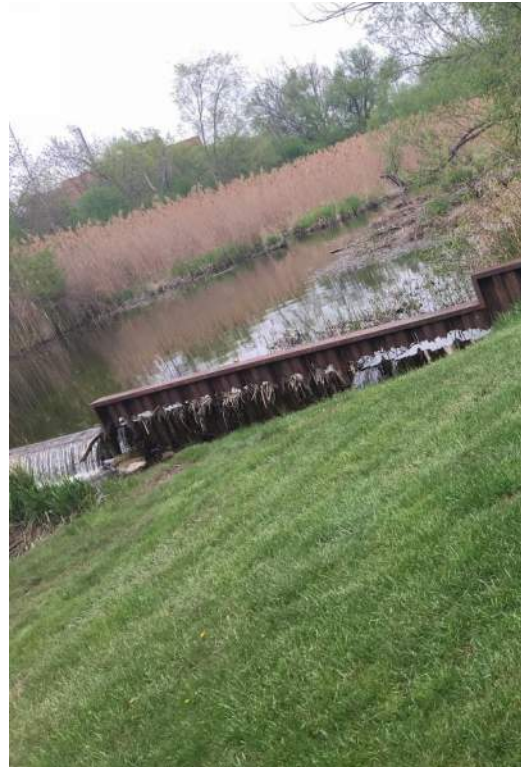
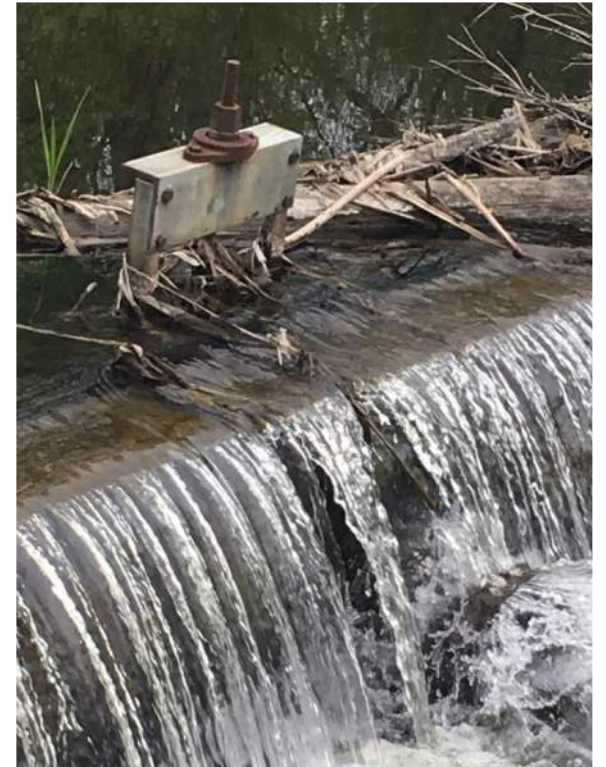
Joachim Drain Weir Pictures at Galloway Lake

In addition, subsequent investigations have found that the weir has significant structural issues that are causing flows to bypass the weir, and it is no longer able to function as designed. The weir should be repaired at the same time as the storm sewer improvements. See Appendix G for photos of the weir condition.

- ≡ Immediate rehabilitation of the weir structure. The weir structure is in a state of failure as shown in the pictures in Appendix G.
- ≡ It would also replace the slide gate that allows for maintenance of levels upstream of the weir.
- ≡ For the purposes of the present worth analysis, an anticipated useful life of 20 years was assumed for the rehabilitated weir and 50 years for the new gate.
- ≡ **This has an estimated capital cost of \$239,000.00.** See Appendix B for additional details.
