AGENDA

Red Run Intercounty Drain Drainage Board Macomb and Oakland Counties

May 17, 2023 – 10:30 a.m.

Flood Damage Reduction Channels: Red Run Drain
For use during Initial and Continuing Eligibility Inspections of flood damage reduction channels

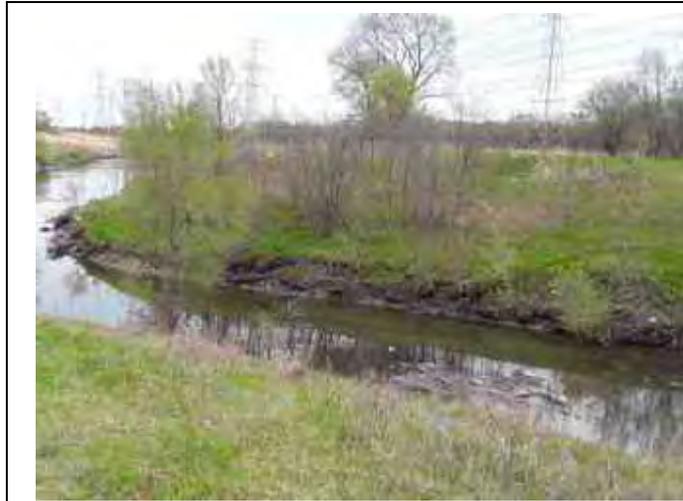
Inspect ID: 2022-0023 **Title:** 2704000028_CELRE_2022_A_0023_3_20220506T170325.jpg
Rated Item: 2. Shoaling (sediment deposition) **Caption:** Minimally Acceptable - Minor shoaling.

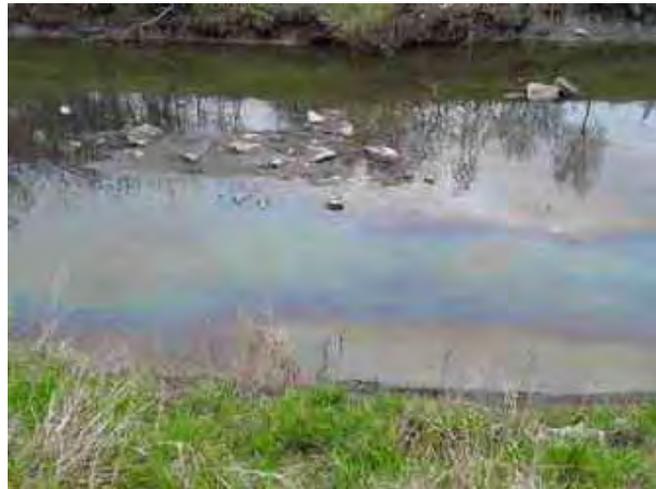
Inspect ID: 2022-0023 **Title:** 2704000028_CELRE_2022_A_2022-0023_4_20220506T170628.jpg **Rated Item:** 2. Shoaling (sediment deposition) **Caption:** Minimally Acceptable - Minor shoaling. Noted oily sheen spill. County reported spill, and had oil booms deployed.

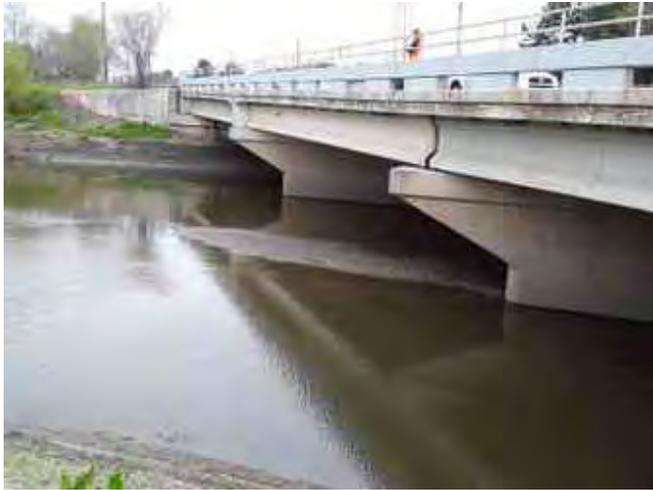
<p>Inspect ID: 2022-0027 Title: 2704000028_CELRE_2022_A_0027_1_20220506T173941.jpg Rated Item: 2. Shoaling (sediment deposition) Caption: Minimally Acceptable - Minor shoaling.</p>

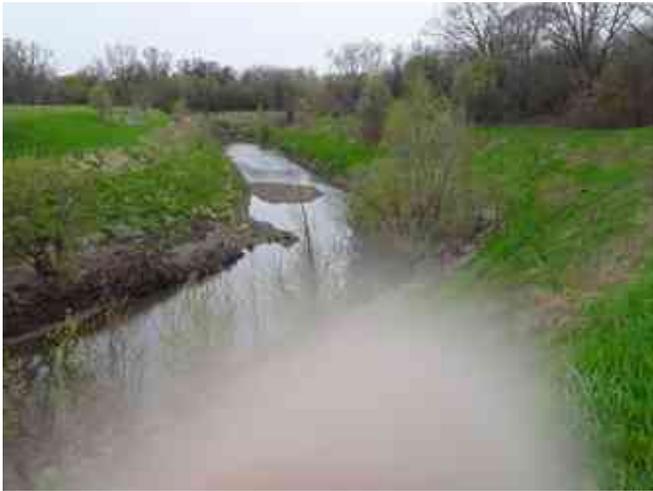
<p>Inspect ID: 2022-0308 Title: 2704000028_CELRE_2022_A_0308_1_20220506T135544.jpg Rated Item: 2. Shoaling (sediment deposition) Caption: Minimally Acceptable - Minor shoaling.</p>

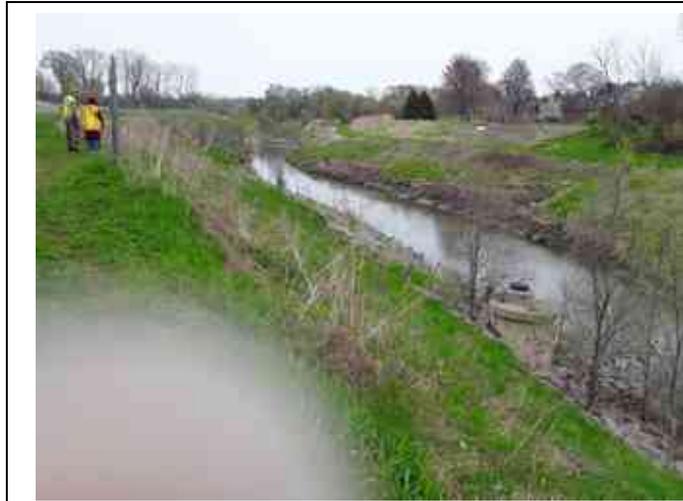
Inspect ID: 2022-0308 **Title:**
2704000028_CELRE_2022_A_0308_2_20220506T135553.jpg
Rated Item: 2. Shoaling (sediment deposition) **Caption:**
Minimally Acceptable - Minor shoaling. Noted manhole location.

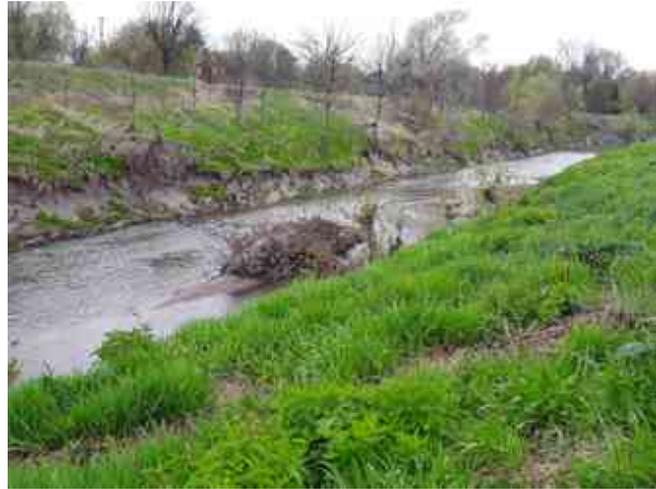
Inspect ID: 2022-0321 **Title:**
2704000028_CELRE_2022_A_0321_1_20220506T143901.jpg
Rated Item: 2. Shoaling (sediment deposition) **Caption:**
Minimally Acceptable - Minor shoaling of channel bottom.

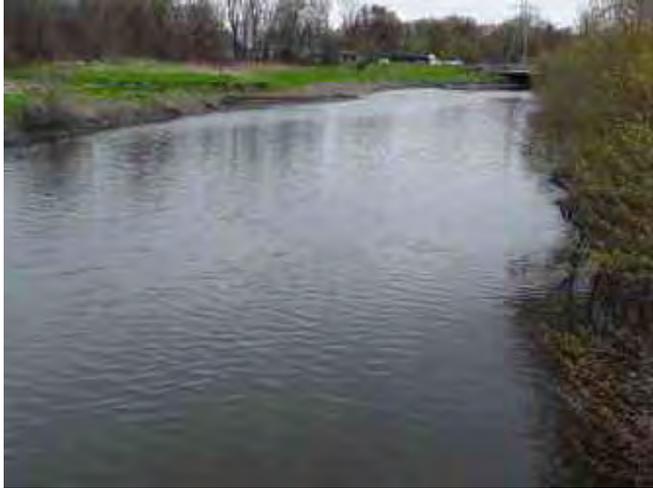
<p>Inspect ID: 2022-0351 Title: 2704000028_CELRE_2022_A_0351_1_20220506T185400.jpg Rated Item: 2. Shoaling (sediment deposition) Caption: Acceptable - No shoaling noted at Metro Parkway Bridge.</p>

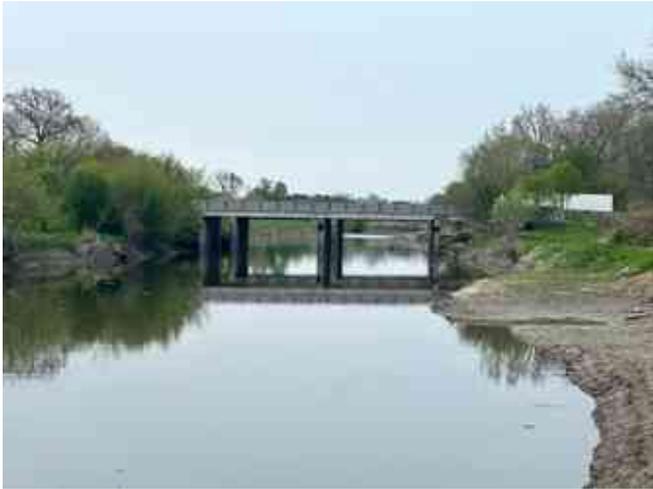
<p>Inspect ID: 2022-0351 Title: 2704000028_CELRE_2022_A_0351_2_20220516T155017.jpg Rated Item: 2. Shoaling (sediment deposition) Caption: Acceptable - No shoaling noted at Metro Parkway Bridge.</p>

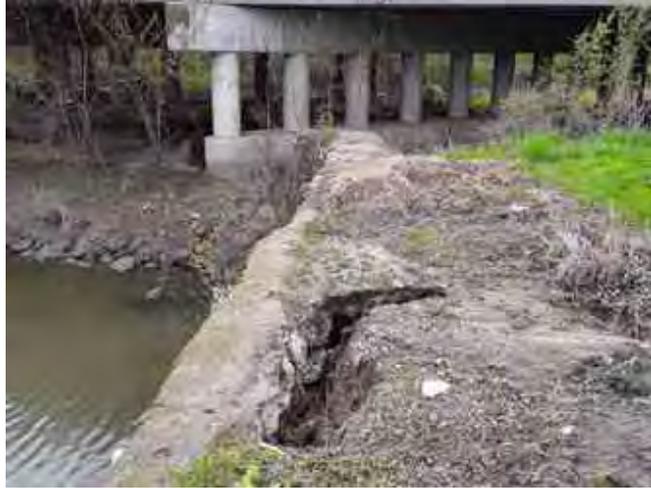
Inspect ID: 2022-0020 **Title:** 2704000028_CELRE_2022_A_0020_2_20220506T163542.jpg
Rated Item: 3. Encroachments **Caption:** Acceptable - An old pump shed noted, sink hole due to corroded pipe underneath. (noted, but not part of project)

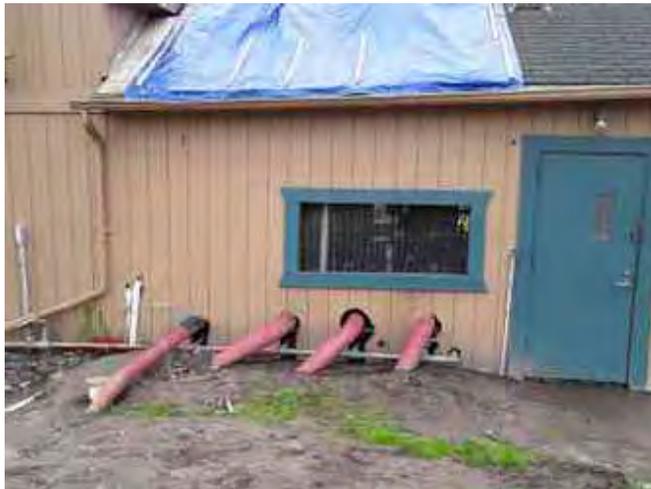
Inspect ID: 2022-0020 **Title:** 2704000028_CELRE_2022_A_2022-0020_6_20220506T163908.jpg **Rated Item:** 3. Encroachments **Caption:** Acceptable - An old pump shed noted, sink hole due to corroded pipe underneath. (noted, but not part of project)

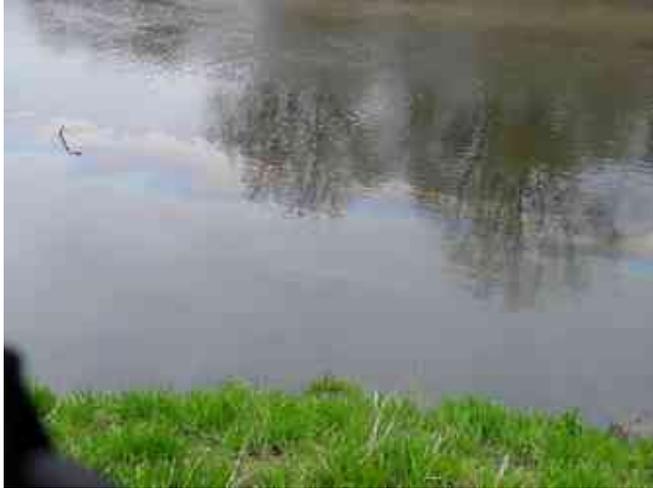
<p>Inspect ID: 2022-0338 Title: 2704000028_CELRE_2022_A_0338_1_20220506T170321.jpg Rated Item: 3. Encroachments Caption: Minimally Acceptable - Oily sheen noted. County reported spill, and had oil booms deployed.</p>

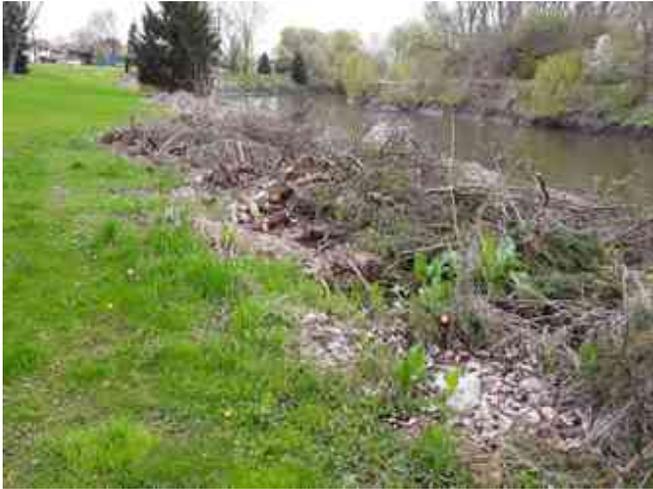
<p>Inspect ID: 2022-0347 Title: 2704000028_CELRE_2022_A_0347_1_20220506T174457.jpg Rated Item: 3. Encroachments Caption: Minimally Acceptable - Dumping of yard waste</p>

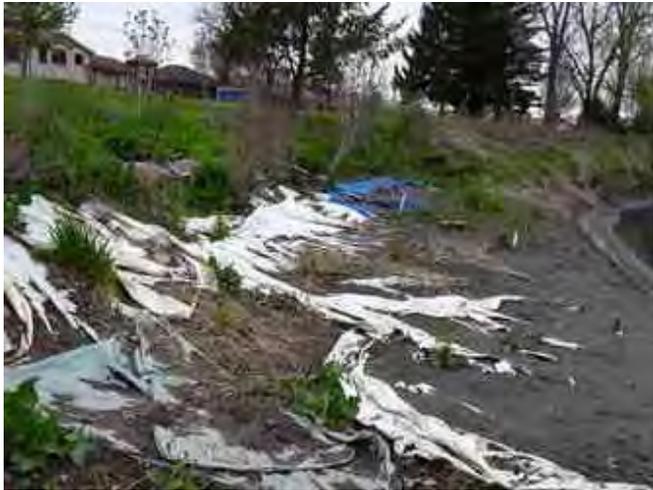
<p>Inspect ID: 2022-0348 Title: 2704000028_CELRE_2022_A_0348_1_20220506T174822.jpg Rated Item: 3. Encroachments Caption: Minimally Acceptable - Plastic tarp on banks prevent vegetation from establishing.</p>

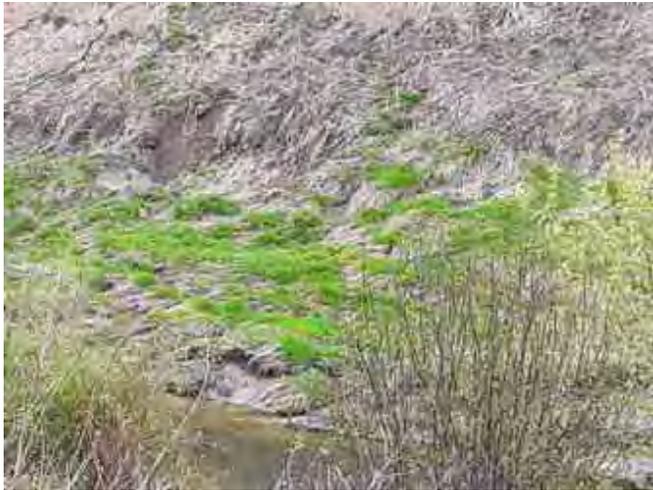
<p>Inspect ID: 2022-0002 Title: 2704000028_CELRE_2022_A_2022-0002_4_20220506T133640.jpg Rated Item: 4. Erosion Caption: Minimally Acceptable - Steep slopes. Toe erosion.</p>

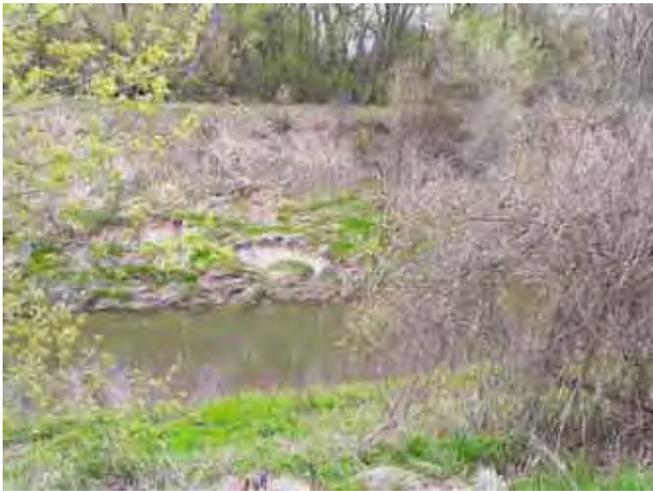
<p>Inspect ID: 2022-0009 Title: 2704000028_CELRE_2022_A_0009_1_20220506T141352.jpg Rated Item: 4. Erosion Caption: Minimally Acceptable - Toe erosion</p>

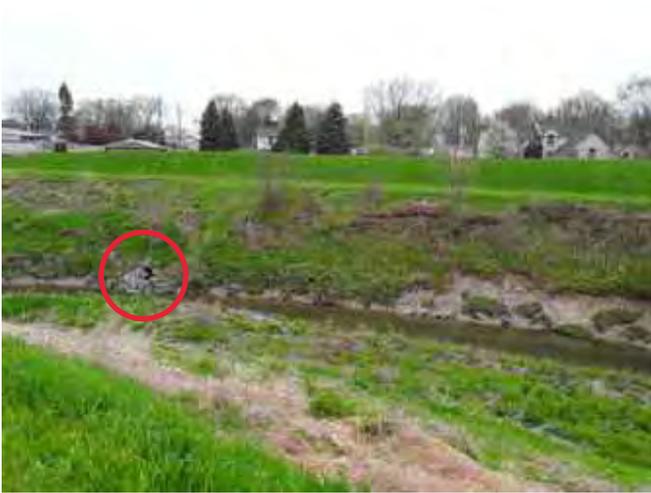
<p>Inspect ID: 2022-0012 Title: 2704000028_CELRE_2022_A_0012_2_20220506T142447.jpg Rated Item: 4. Erosion Caption: Minimally Acceptable - Toe erosion. Outlet location noticed.</p>

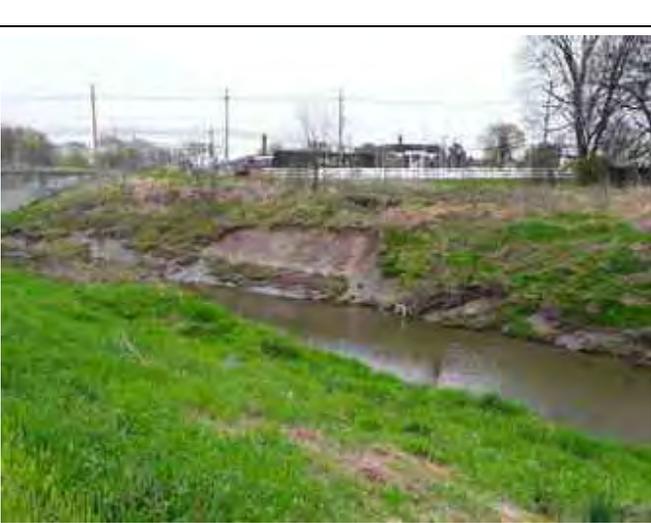
<p>Inspect ID: 2022-0013 Title: 2704000028_CELRE_2022_A_0013_1_20220506T143838.jpg Rated Item: 4. Erosion Caption: Minimally Acceptable - Bank erosion.</p>

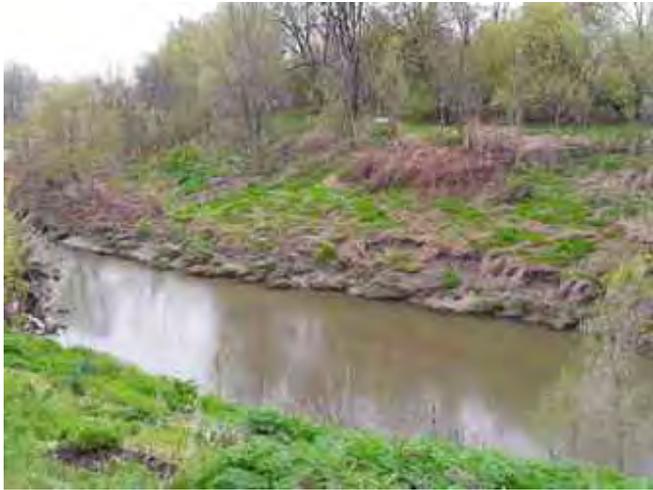
A photograph showing a riverbank with significant erosion. The water is murky brown, and the bank is composed of exposed soil and some sparse green vegetation. The background shows a line of trees.	<p>Inspect ID: 2022-0014 Title: 2704000028_CELRE_2022_A_0014_1_20220506T145729.jpg Rated Item: 4. Erosion Caption: Minimally Acceptable - Bank and toe erosion.</p>

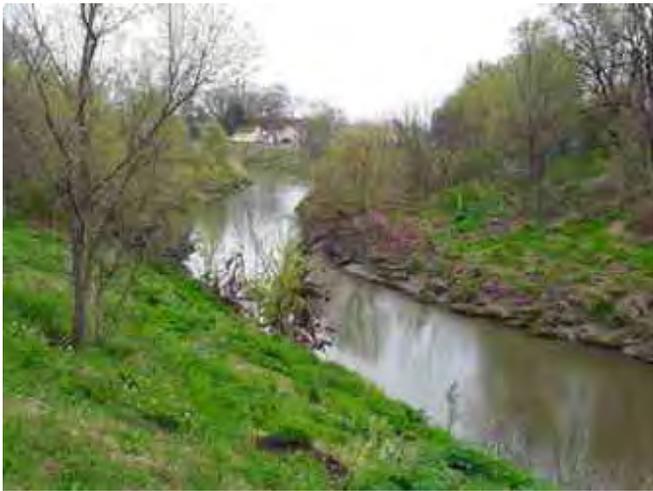
A photograph showing a riverbank with significant erosion. The water is murky brown, and the bank is composed of exposed soil and some sparse green vegetation. The background shows a line of trees.	<p>Inspect ID: 2022-0014 Title: 2704000028_CELRE_2022_A_0014_2_20220506T145740.jpg Rated Item: 4. Erosion Caption: Minimally Acceptable - Bank and toe erosion.</p>

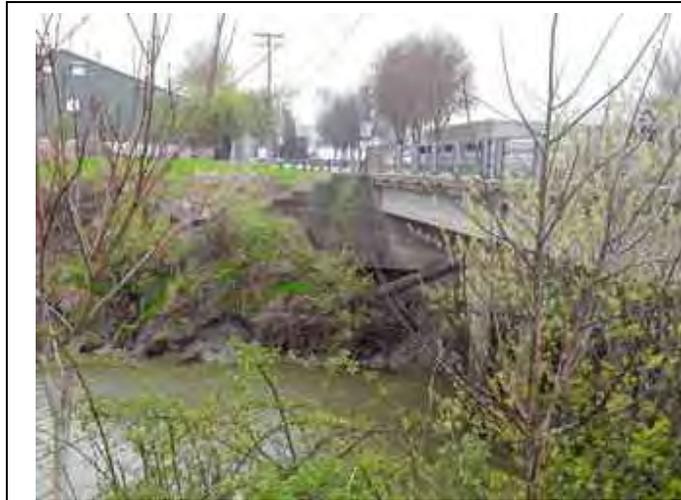
Inspect ID: 2022-0017 **Title:**
2704000028_CELRE_2022_A_0017_1_20220506T151555.jpg
Rated Item: 4. Erosion **Caption:** Minimally Acceptable -
Bank and toe erosion under Denton Dr bridge.

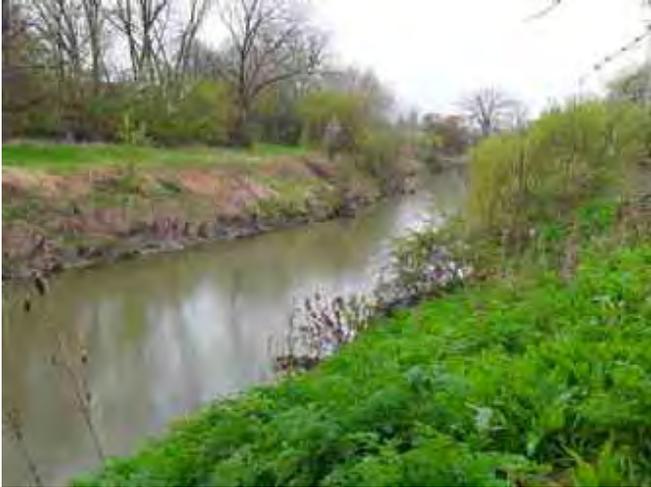
<p>Inspect ID: 2022-0018 Title: 2704000028_CELRE_2022_A_0018_1_20220506T152558.jpg Rated Item: 4. Erosion Caption: Minimally Acceptable - Typical condition of toe erosion.</p>

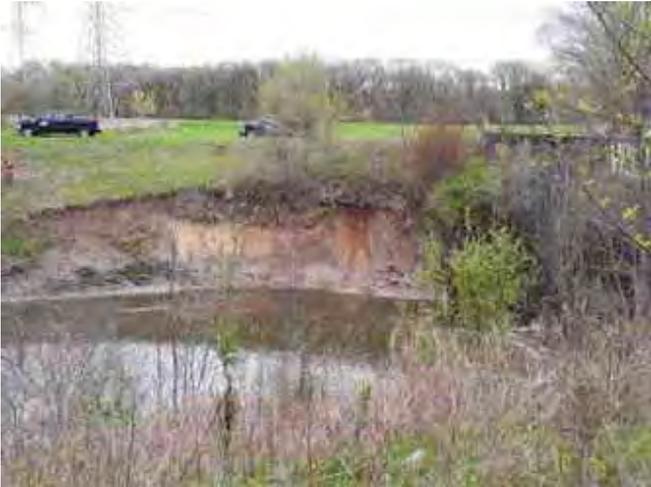
<p>Inspect ID: 2022-0021 Title: 2704000028_CELRE_2022_A_0021_1_20220506T170005.jpg Rated Item: 4. Erosion Caption: Unacceptable - Bank failure. Recommend closing access road.</p>

Rated Item	Rating	Rating Guidelines		Location/Remarks/Recommendations
				2022-0325 : Toe erosion. (M) 2022-0327 : Toe erosion. (M) 2022-0329 : Typical erosion. (M) 2022-0330 : Slope failure (M) 2022-0331 : Eroded slope. (M) 2022-0332 : Toe erosion and rust colored seepage noted. (M) 2022-0333 : Typical erosion of banks. (M) 2022-0339 : Slope failure on high bank (U) 2022-0340 : Erosion and oil sheen noted. County reported spill, and had oil booms deployed. (M) 2022-0341 : High, deep slope failure. (U) 2022-0342 : Depression on bank. (M) 2022-0344 : Steep slopes. Bank erosion. (M) 2022-0345 : Eroded banks. (M) 2022-0349 : Toe erosion. (M) 2022-0350 : Eroded banks. (M) Justification: No head cutting or horizontal deviation was noted on the channel bottom. However, significant erosion and slope failures were noted throughout the project. NOTE: We strongly recommend closing access roads along the top of the unstable banks to vehicles.

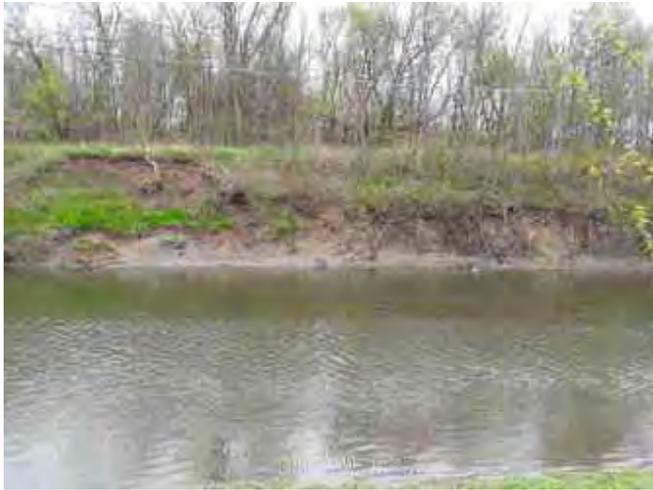
A photograph showing a riverbank with significant erosion. The bank is composed of dark soil and is partially covered with green vegetation. The water is calm and reflects the sky.	<p>Inspect ID: 2022-0024 Title: 2704000028_CELRE_2022_A_0024_1_20220506T172249.jpg Rated Item: 4. Erosion Caption: Minimally Acceptable - Bank and toe erosion.</p>

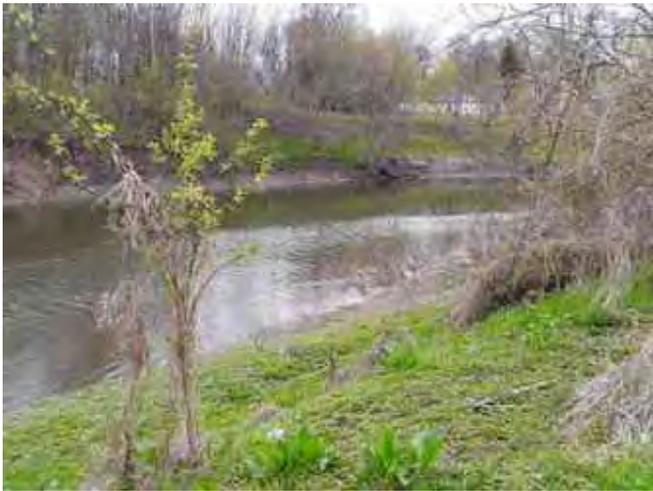
A photograph showing a riverbank with erosion. The bank is covered with green grass and some small trees. The water is calm and reflects the sky.	<p>Inspect ID: 2022-0024 Title: 2704000028_CELRE_2022_A_0024_2_20220506T172301.jpg Rated Item: 4. Erosion Caption: Minimally Acceptable - Bank and toe erosion.</p>

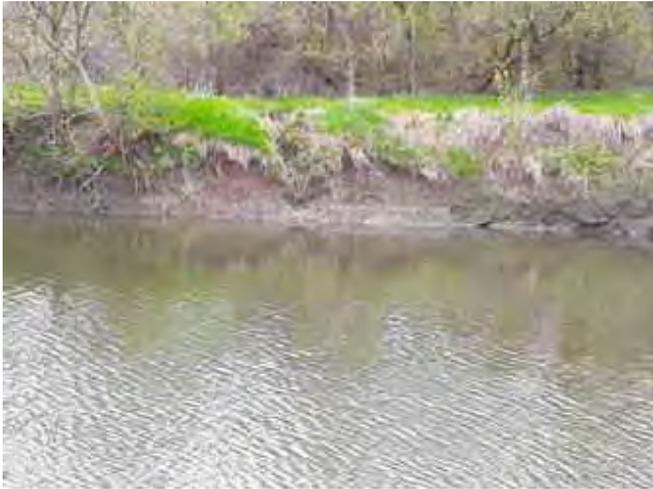
<p>Inspect ID: 2022-0025 Title: 2704000028_CELRE_2022_A_0025_1_20220506T172615.jpg Rated Item: 4. Erosion Caption: Minimally Acceptable - Typical conditions of bank erosion.</p>

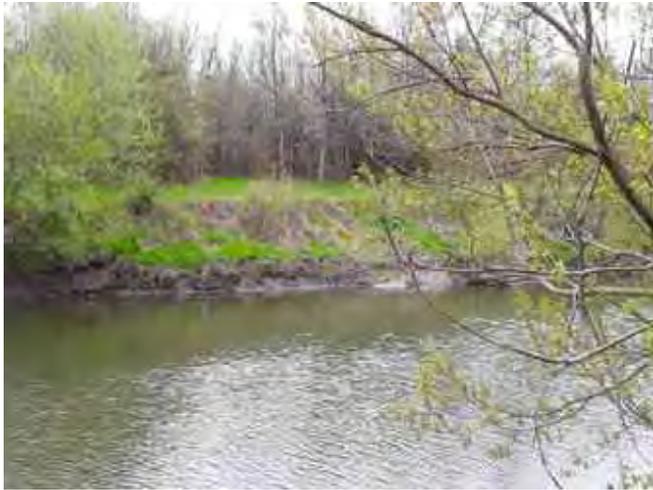
<p>Inspect ID: 2022-0025 Title: 2704000028_CELRE_2022_A_0025_2_20220506T172630.jpg Rated Item: 4. Erosion Caption: Minimally Acceptable - Typical conditions of bank erosion.</p>

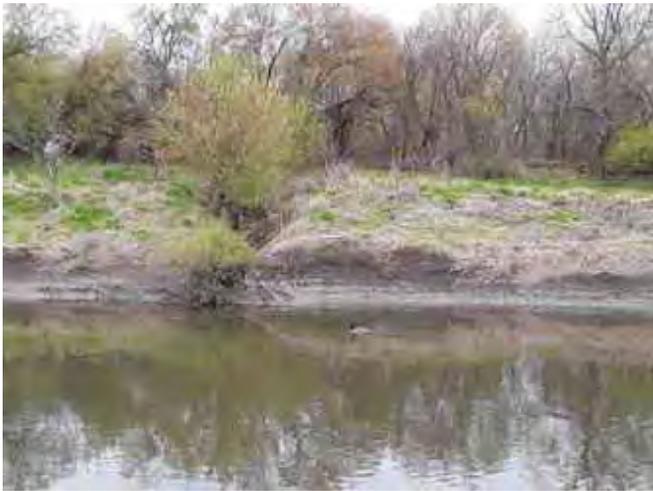
<p>Inspect ID: 2022-0026 Title: 2704000028_CELRE_2022_A_0026_1_20220506T173553.jpg Rated Item: 4. Erosion Caption: Minimally Acceptable - Large depression on bank.</p>

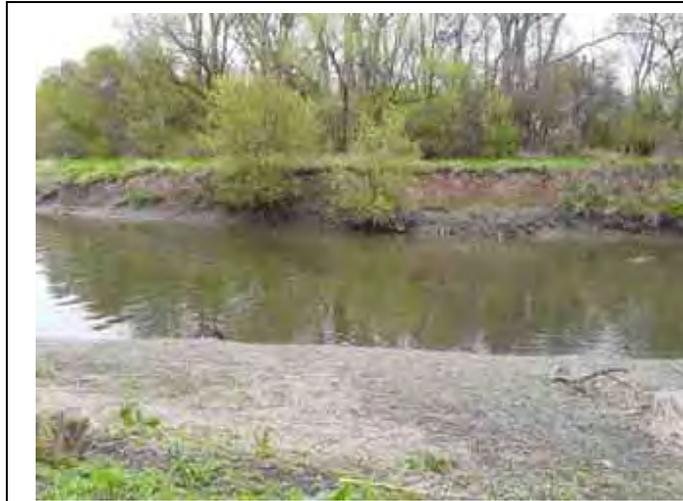
Inspect ID: 2022-0029 **Title:**
2704000028_CELRE_2022_A_0029_3_20220506T174726.jpg
Rated Item: 4. Erosion **Caption:** Minimally Acceptable - Eroded banks

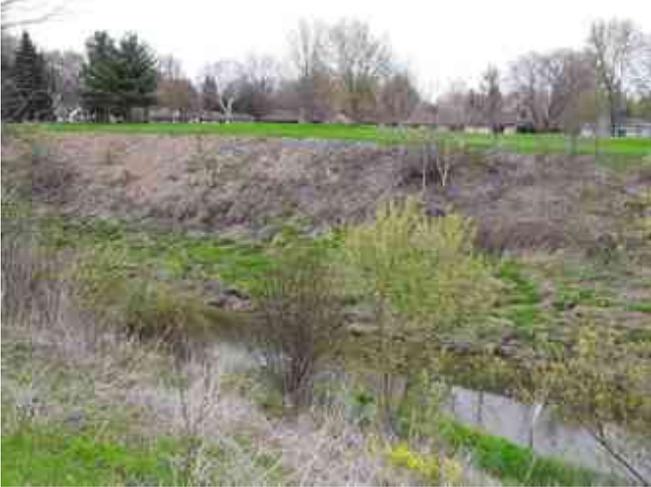
<p>Inspect ID: 2022-0301 Title: 2704000028_CELRE_2022_A_0301_1_20220506T133537.jpg Rated Item: 4. Erosion Caption: Minimally Acceptable - Erosion, slope stability. Overly steep slopes with past failures.</p>

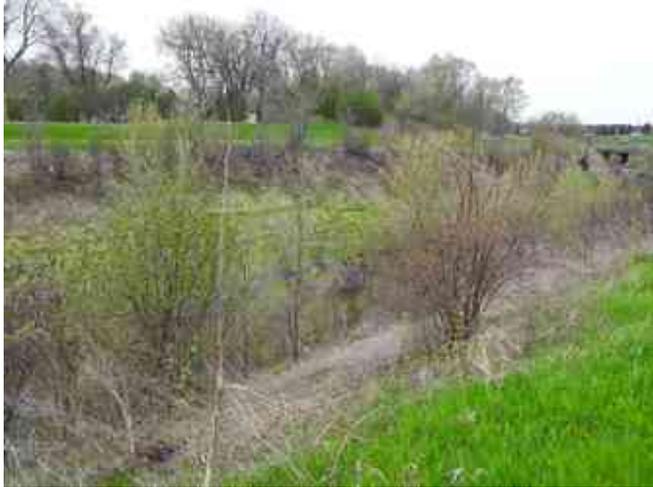
<p>Inspect ID: 2022-0301 Title: 2704000028_CELRE_2022_A_0301_2_20220506T133550.jpg Rated Item: 4. Erosion Caption: Minimally Acceptable - Erosion, slope stability. Overly steep slopes with past failures.</p>

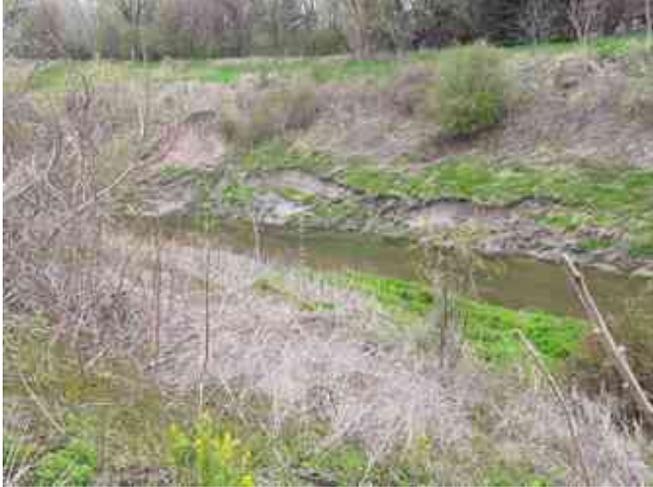
<p>Inspect ID: 2022-0302 Title: 2704000028_CELRE_2022_A_0302_1_20220506T133909.jpg Rated Item: 4. Erosion Caption: Minimally Acceptable - Slope failures.</p>

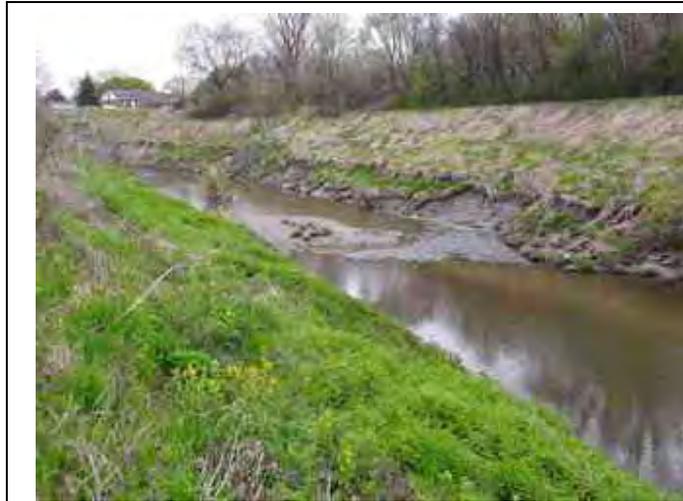
Inspect ID: 2022-0303 **Title:**
2704000028_CELRE_2022_A_0303_1_20220506T134246.jpg
Rated Item: 4. Erosion **Caption:** Minimally Acceptable - Toe erosion.

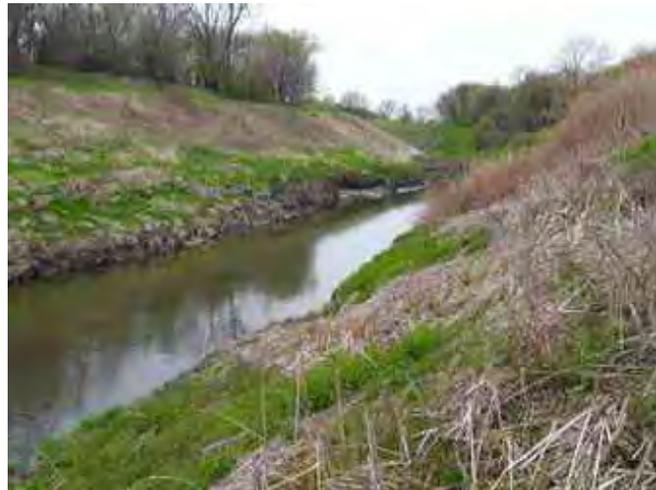
Inspect ID: 2022-0303 **Title:**
2704000028_CELRE_2022_A_0303_2_20220506T134301.jpg
Rated Item: 4. Erosion **Caption:** Minimally Acceptable - Toe erosion.

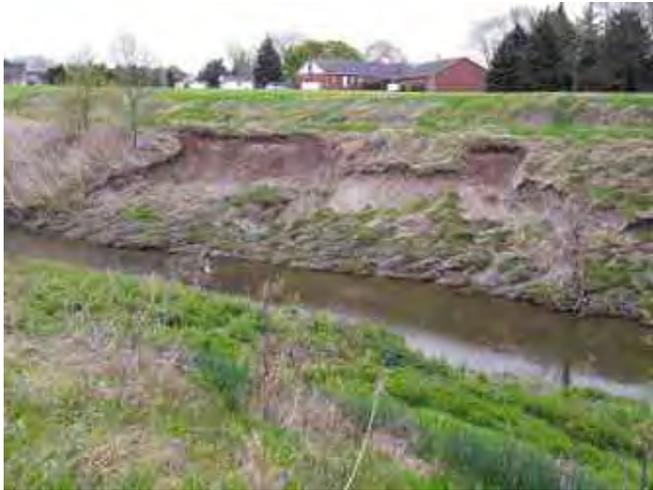
<p>Inspect ID: 2022-0304 Title: 2704000028_CELRE_2022_A_0304_1_20220506T134650.jpg Rated Item: 4. Erosion Caption: Unacceptable - Heavier erosion of bank. Access road unsafe.</p>

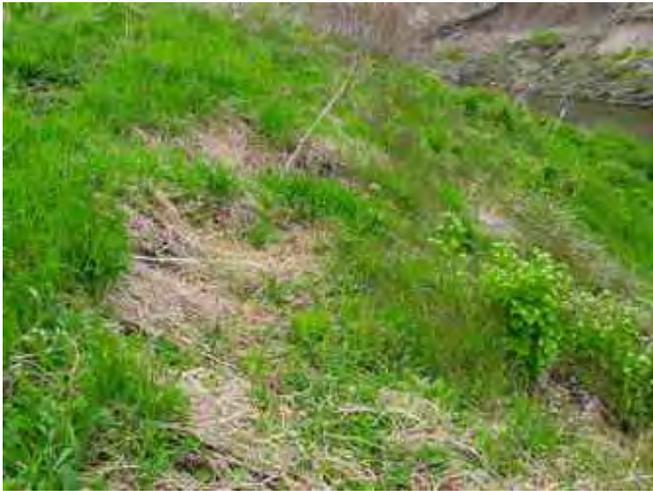
<p>Inspect ID: 2022-0305 Title: 2704000028_CELRE_2022_A_0305_1_20220506T134814.jpg Rated Item: 4. Erosion Caption: Minimally Acceptable - Recent slope failure.</p>

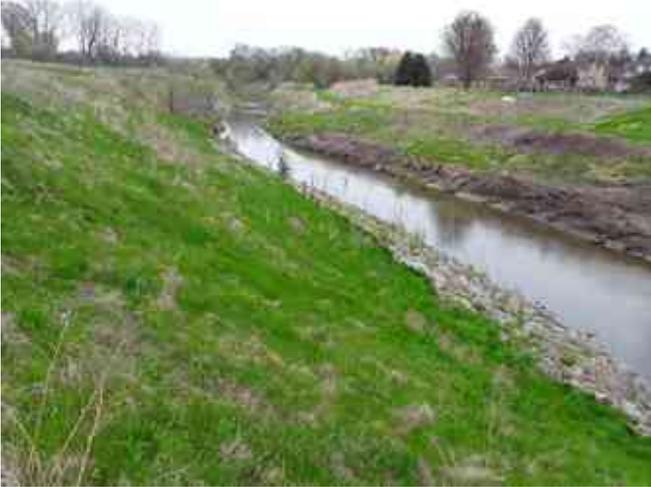
<p>Inspect ID: 2022-0309 Title: 2704000028_CELRE_2022_A_0309_1_20220506T135653.jpg Rated Item: 4. Erosion Caption: Acceptable - Repaired areas stable.</p>

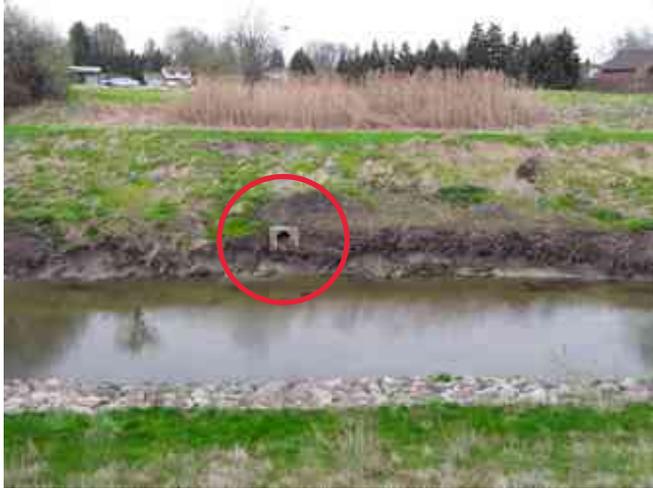
<p>Inspect ID: 2022-0313 Title: 2704000028_CELRE_2022_A_0311_1_20220506T140545.jpg Rated Item: 4. Erosion Caption: Minimally Acceptable - Toe erosion. Outlet location also noted.</p>

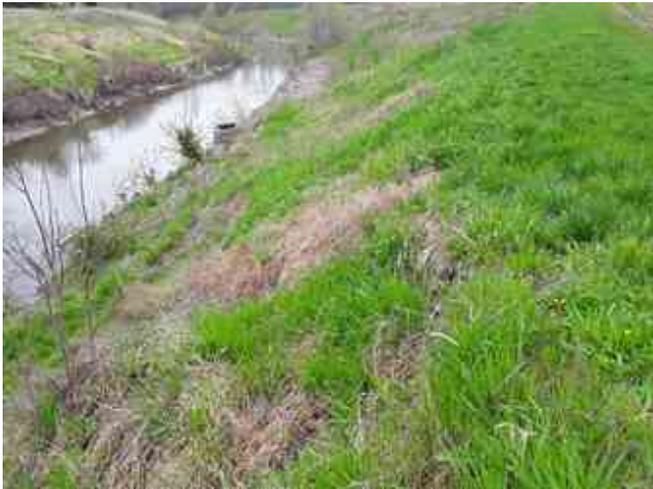
<p>Inspect ID: 2022-0314 Title: 2704000028_CELRE_2022_A_0314_1_20220506T140854.jpg Rated Item: 4. Erosion Caption: Minimally Acceptable - Recent failure</p>

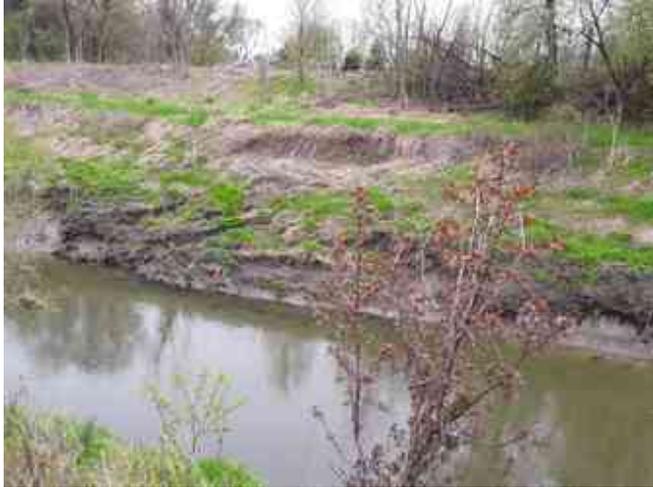
<p>Inspect ID: 2022-0315 Title: 2704000028_CELRE_2022_A_0315_1_20220506T140928.jpg Rated Item: 4. Erosion Caption: Minimally Acceptable - Bank failure.</p>

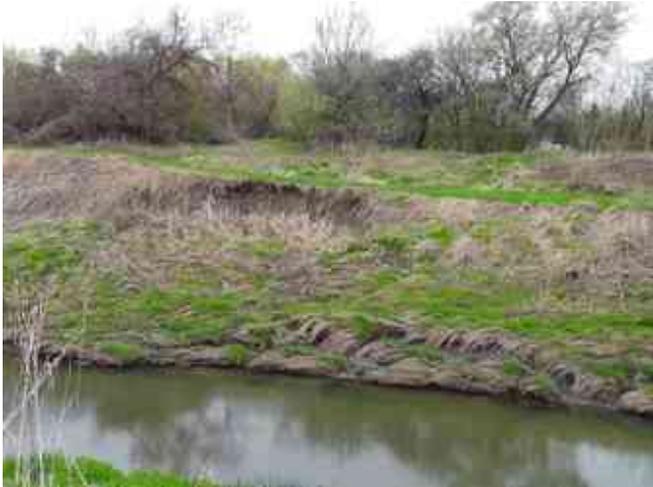
<p>Inspect ID: 2022-0316 Title: 2704000028_CELRE_2022_A_0316_1_20220506T141036.jpg Rated Item: 4. Erosion Caption: Unacceptable - Bank failure.</p>

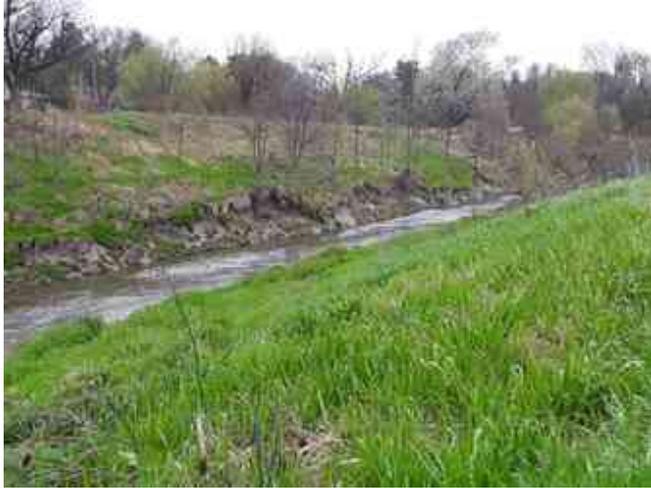
Inspect ID: 2022-0320 **Title:** 2704000028_CELRE_2022_A_0320_2_20220506T143620.jpg
Rated Item: 4. Erosion **Caption:** Unacceptable - Heavier slope failure, bank and toe.

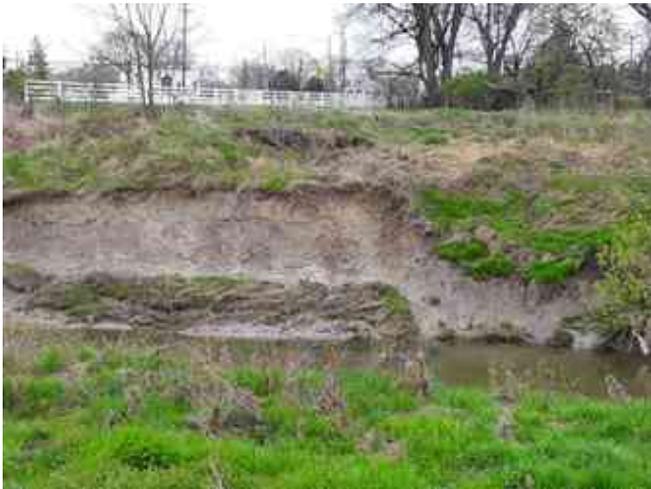
Inspect ID: 2022-0320 **Title:** 2704000028_CELRE_2022_A_0320_3_20220506T143633.jpg
Rated Item: 4. Erosion **Caption:** Unacceptable - Heavier slope failure, bank and toe.

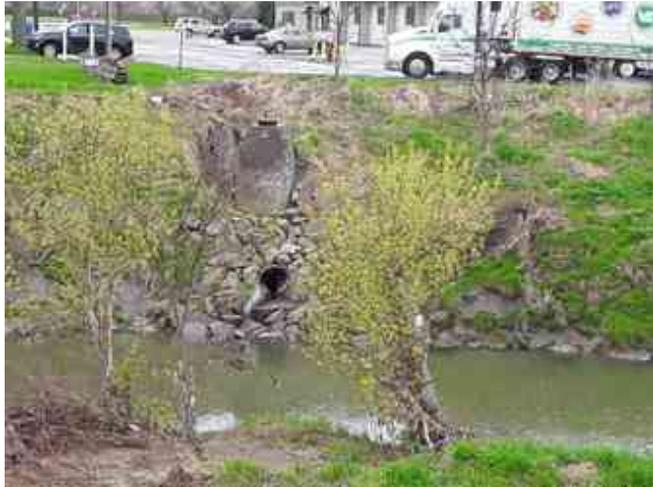
Rated Item	Rating	Rating Guidelines		Location/Remarks/Recommendations
4. Erosion	U	A	No head cutting or horizontal deviation observed.	2022-0002 : Steep slopes. Toe erosion. (M)
		M	Head cutting and horizontal deviation evident, but is less than 1 foot from the designed grade or cross section.	2022-0009 : Toe erosion (M) 2022-0011 : Bank erosion. (M) 2022-0012 : Toe erosion. Outlet location noticed. (M)
		U	Head cutting and horizontal deviation of more than 1 foot from the designed grade or cross section. Corrective actions required to stop or slow erosion.	2022-0013 : Bank erosion. (M) 2022-0014 : Bank and toe erosion. (M) 2022-0015 : Sloughing of bank. (M) 2022-0017 : Bank and toe erosion under Denton Dr bridge. (M) 2022-0018 : Typical condition of toe erosion. (M) 2022-0021 (U) 2022-0024 : Bank and toe erosion. (M) 2022-0025 : Typical conditions of bank erosion. (M) 2022-0026 : Large depression on bank. (M) 2022-0029 : Eroded banks. (M) 2022-0300 : Toe erosion. (M) 2022-0301 : Erosion, slope stability. Overly steep slopes with past failures. (M) 2022-0302 : Slope failures. (M) 2022-0303 : S : Toe erosion. (M) 2022-0304 : Heavier erosion of bank. Access road unsafe. (U) 2022-0305 : Recent slope failure. (M) 2022-0306 : Toe and bank erosion. (M) 2022-0309 : Repaired areas stable. (A) 2022-0310 : Typical erosion. (M) 2022-0313 : Toe erosion. Outlet location also noted. (M) 2022-0314 : Recent failure (M) 2022-0315 : Bank failure. (M) 2022-0316 : Bank failure. (U) 2022-0317 : Toe erosion. (M) 2022-0319 : Toe erosion. (M) 2022-0320 : Heavier slope failure, bank and toe. (U) 2022-0323 : Recent slope failure (U) 2022-0324 : Heavy erosion around manhole (M)

Inspect ID: 2022-0324 **Title:**
2704000028_CELRE_2022_A_0324_1_20220506T150033.jpg
Rated Item: 4. Erosion **Caption:** Minimally Acceptable - Heavy erosion around manhole

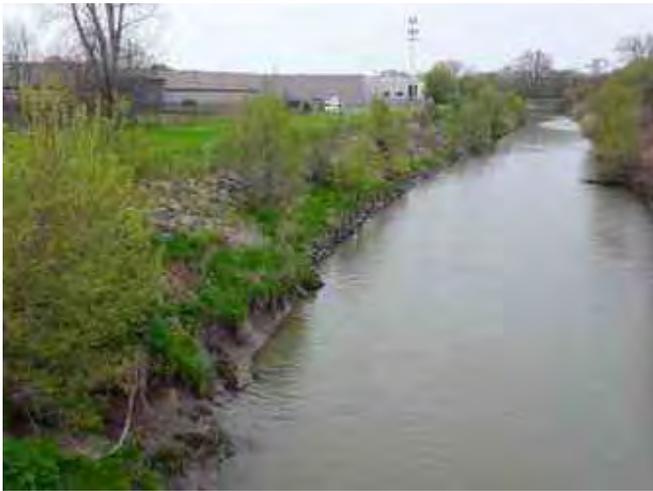
<p>Inspect ID: 2022-0327 Title: 2704000028_CELRE_2022_A_0327_1_20220506T151555.jpg Rated Item: 4. Erosion Caption: Minimally Acceptable - Toe erosion.</p>

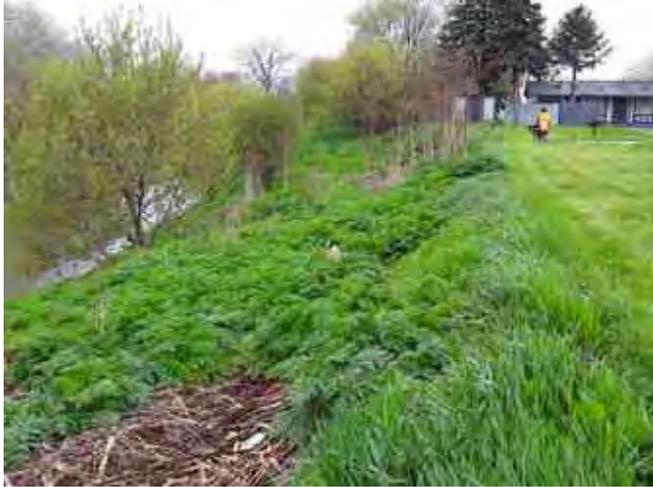
<p>Inspect ID: 2022-0330 Title: 2704000028_CELRE_2022_A_0330_1_20220506T152906.jpg Rated Item: 4. Erosion Caption: Minimally Acceptable - Slope failure</p>

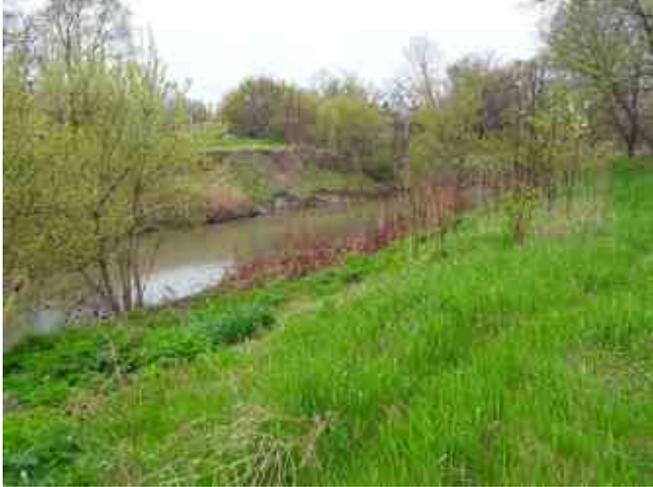
<p>Inspect ID: 2022-0331 Title: 2704000028_CELRE_2022_A_0331_1_20220506T153227.jpg Rated Item: 4. Erosion Caption: Minimally Acceptable - Eroded slope.</p>

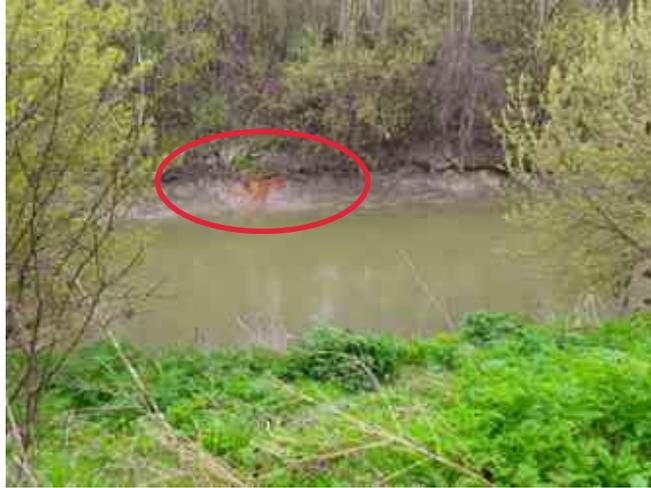
Inspect ID: 2022-0332 **Title:**
2704000028_CELRE_2022_A_0332_1_20220506T153345.jpg
Rated Item: 4. Erosion **Caption:** Minimally Acceptable - Toe erosion and rust colored seepage noted.

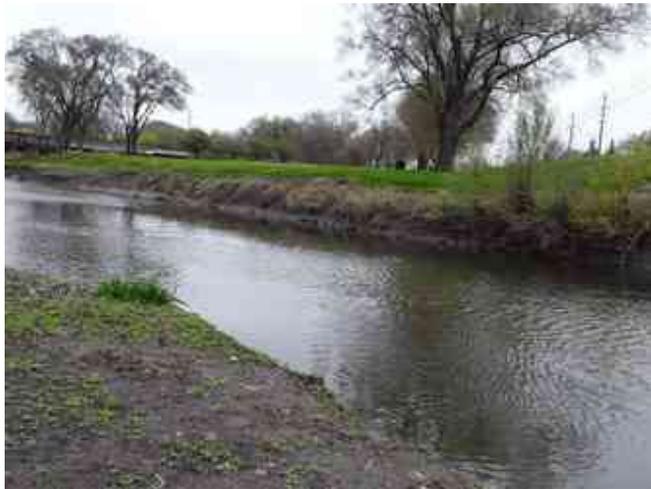
Inspect ID: 2022-0333 **Title:**
2704000028_CELRE_2022_A_0333_1_20220506T163729.jpg
Rated Item: 4. Erosion **Caption:** Minimally Acceptable - Typical erosion of banks.

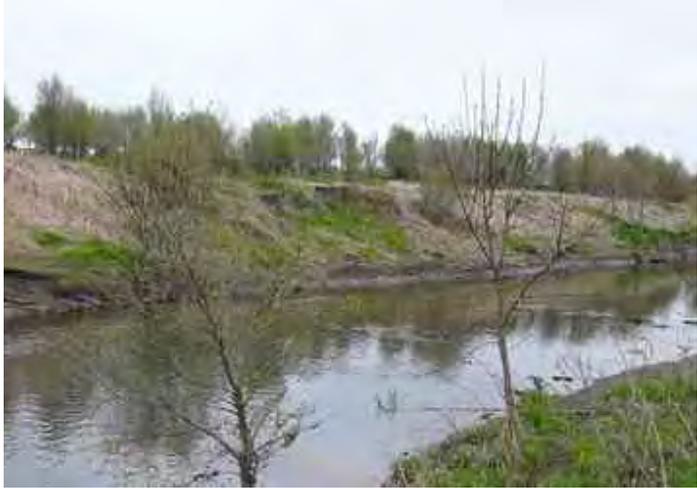
<p>Inspect ID: 2022-0339 Title: 2704000028_CELRE_2022_A_0339_1_20220506T170436.jpg Rated Item: 4. Erosion Caption: Unacceptable - Slope failure on high bank</p>

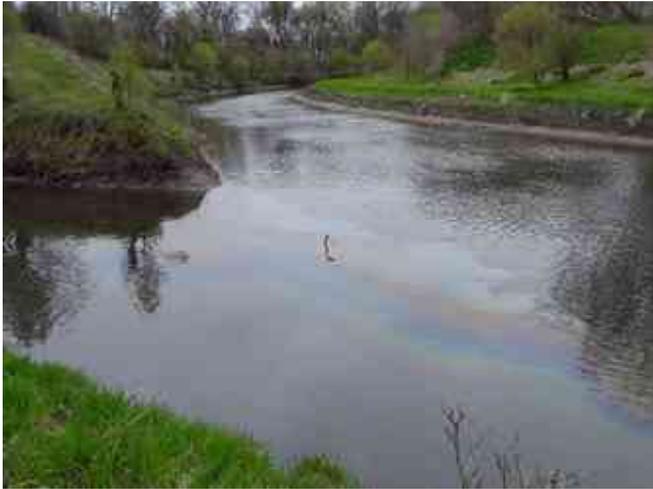
<p>Inspect ID: 2022-0340 Title: 2704000028_CELRE_2022_A_0340_1_20220506T170604.jpg Rated Item: 4. Erosion Caption: Minimally Acceptable - Erosion and oil sheen noted. County reported spill, and had oil booms deployed.</p>

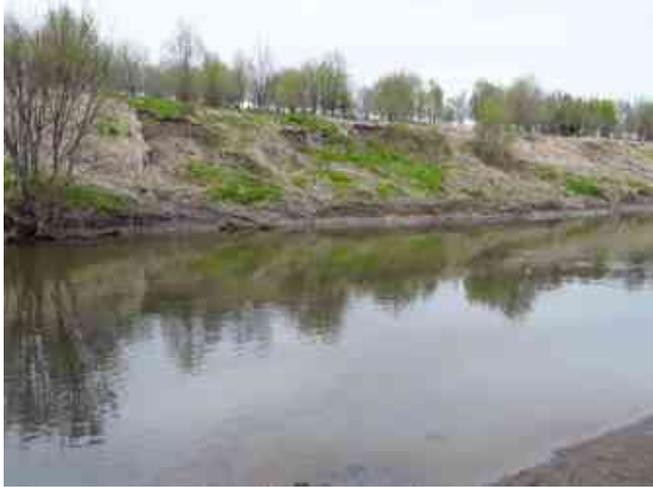
<p>Inspect ID: 2022-0341 Title: 2704000028_CELRE_2022_A_0341_1_20220506T170800.jpg Rated Item: 4. Erosion Caption: Unacceptable - High, deep slope failure.</p>

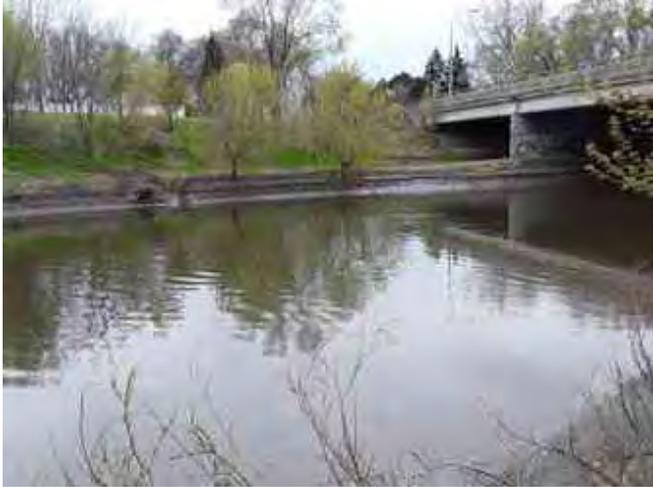
<p>Inspect ID: 2022-0342 Title: 2704000028_CELRE_2022_A_0342_1_20220506T172428.jpg Rated Item: 4. Erosion Caption: Minimally Acceptable - Depression on bank.</p>

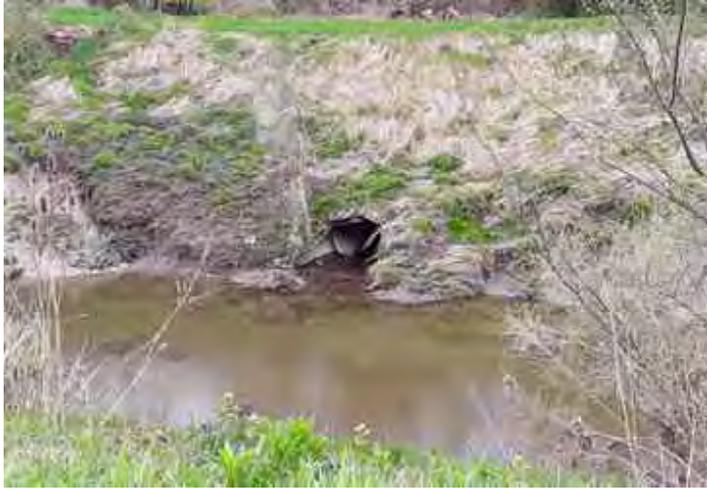
Inspect ID: 2022-0004 **Title:**
2704000028_CELRE_2022_A_0004_1_20220506T134537.jpg
Rated Item: 9. Flap Gates/ Flap Valves/ Pinch Valves
Caption: Minimally Acceptable - Outfall in poor condition.

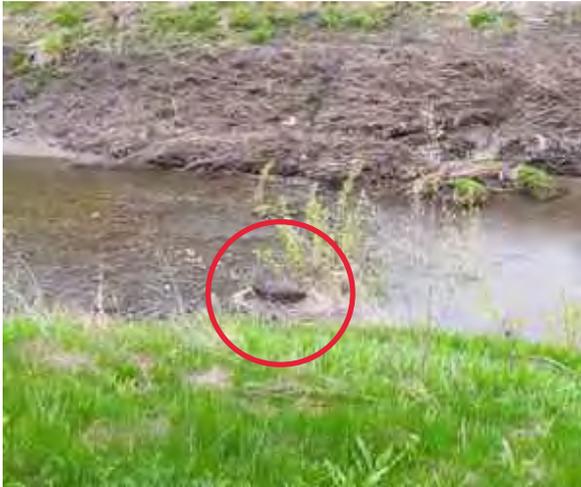
Inspect ID: 2022-0008 **Title:**
2704000028_CELRE_2022_A_0008_2_20220506T140458.jpg
Rated Item: 9. Flap Gates/ Flap Valves/ Pinch Valves
Caption: Acceptable - Manhole location.

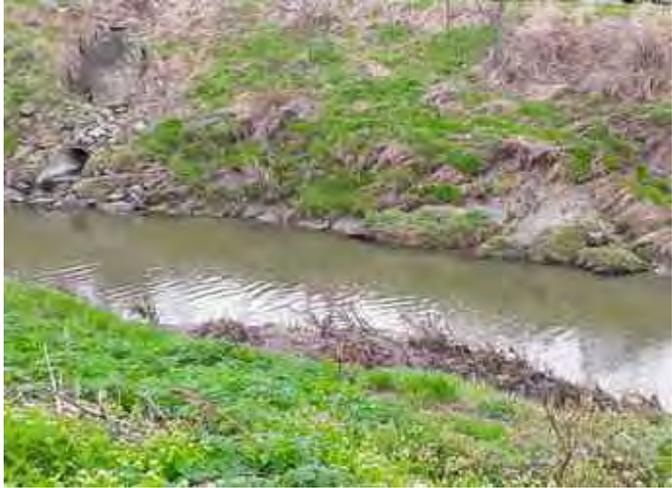
<p>Inspect ID: 2022-0016 Title: 2704000028_CELRE_2022_A_0016_1_20220506T150311.jpg Rated Item: 9. Flap Gates/ Flap Valves/ Pinch Valves Caption: Acceptable - Sediment deposition near left riverbank toe.</p>

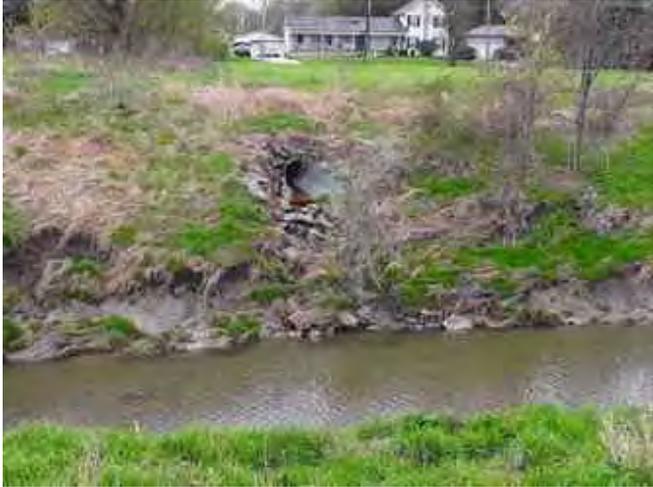
<p>Inspect ID: 2022-0322 Title: 2704000028_CELRE_2022_A_0322_1_20220506T144206.jpg Rated Item: 9. Flap Gates/ Flap Valves/ Pinch Valves Caption: Minimally Acceptable - Erosion around pipe noted.</p>

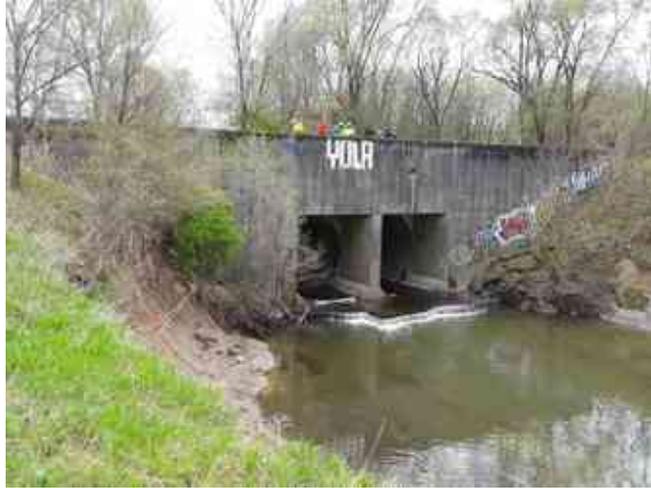
Inspect ID: 2022-0337 **Title:**
2704000028_CELRE_2022_A_0337_1_20220506T165923.jpg
Rated Item: 9. Flap Gates/ Flap Valves/ Pinch Valves
Caption: Acceptable - Macomb County Drain discharge point to the Red Run Drain. Not part of USACE constructed project. Oily sheen noted and reported.
