TO: Karen Mondora, ARC Technical Committee Chair
FROM: Emily Levine, Technical Committee Coordinator
DATE: February 15, 2023
SUBJECT: 2022 IDEP Investigation Summary

Attachment A
Community-specific Investigation Reports

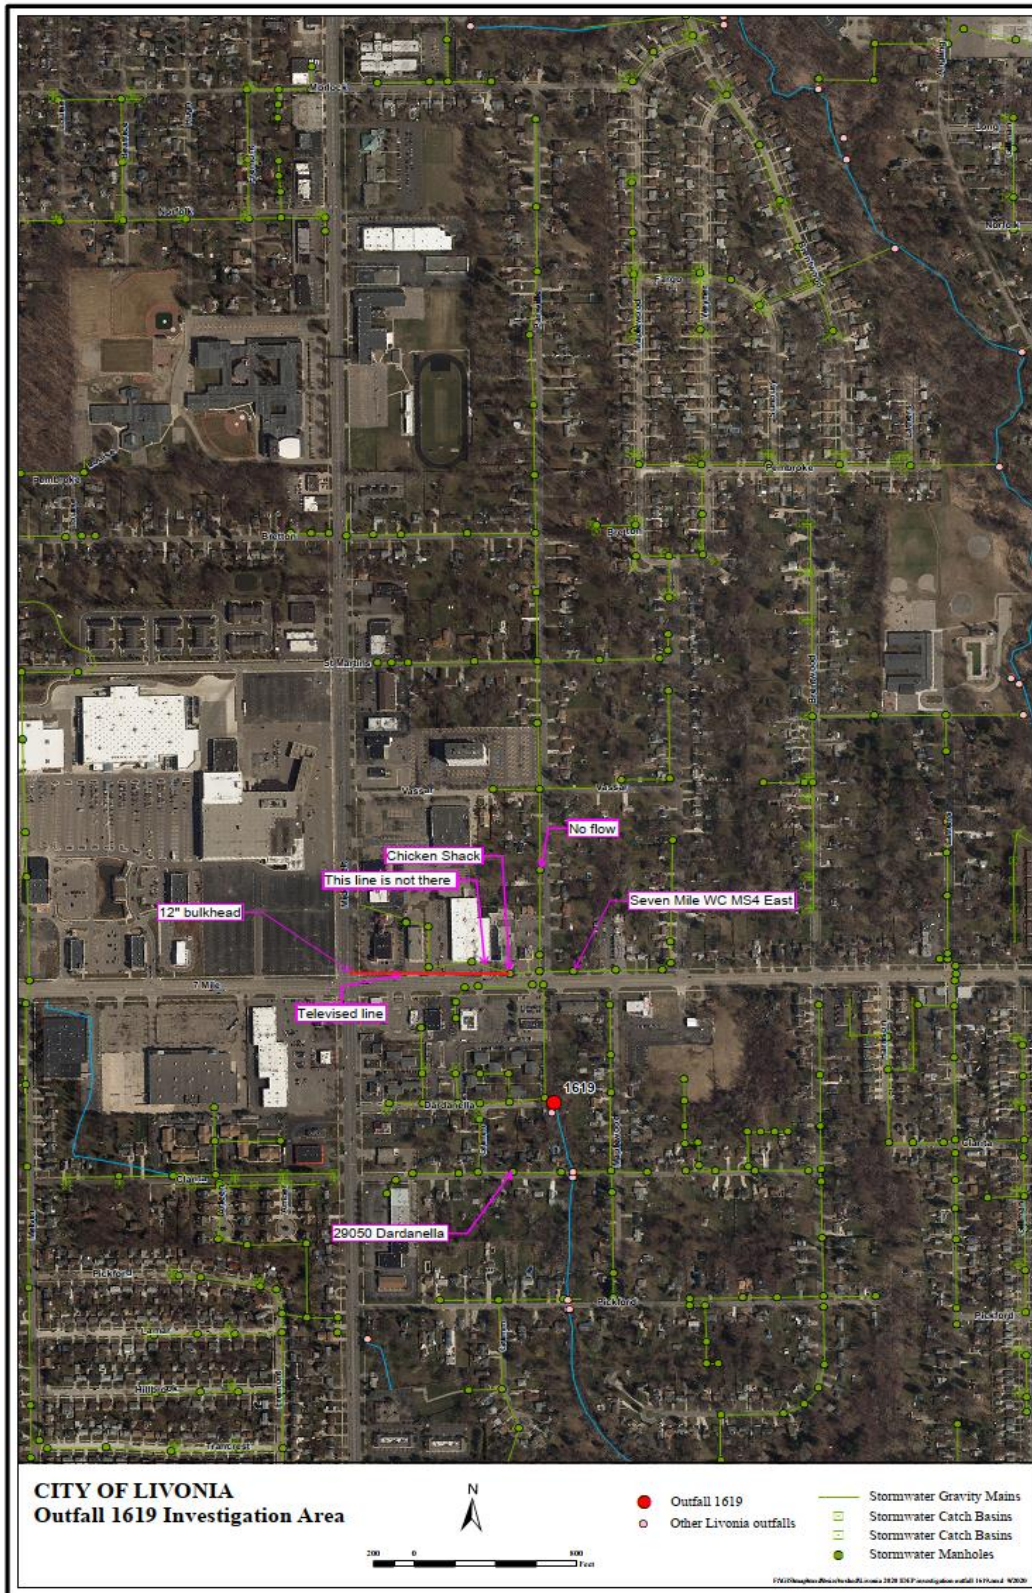
Figure 1. Storm Drain and Sampling Location

Outfall L1619 was investigated due to the high *E. coli* concentrations found during the outfall survey conducted in 2018. At that time, the *E. coli* concentration was 15,531 MPN/100 ml which is indicative of an illicit discharge containing sanitary sewage. Wayne County conducted follow-up investigations, which narrowed down the source to being upstream of a manhole located in the grass along the north side of Seven Mile Road, near a Chicken Shack restaurant (Figure 1). *E. coli* and Human *Bacteroides* levels at this manhole have been found to be elevated (Table 1).

The drainage area of the manhole in front of the Chicken Shack was unclear, as the storm drain map provided by the City of Livonia appears to be incomplete. Therefore, televising was recommended to determine the extent of the storm drain and search for any illicit connections.

The source of the elevated *E. coli* at this outfall remains unclear. Additional inspections of catch basins and their connections along Seven Mile Road, upstream of the Chicken Shack are recommended.

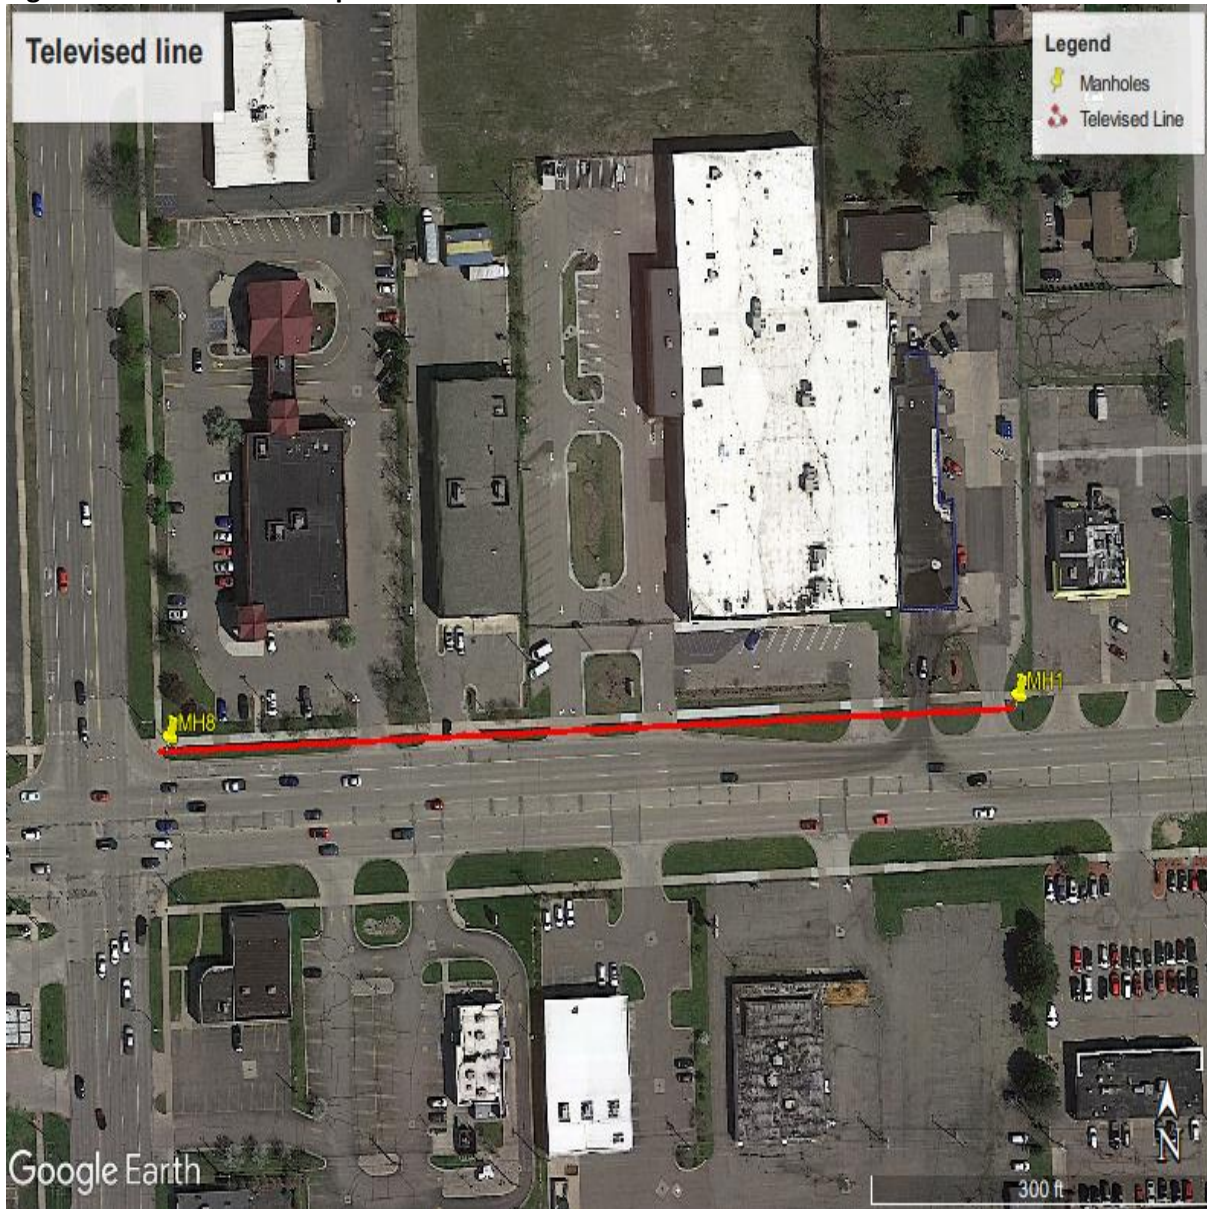
Figure 2. Televised Line Map

ECT worked with a televising crew on December 21, 2022 to televise the line starting at the manhole by the Chicken Shack along Seven Mile Road and ending at Middlebelt Road (Figure 2). Eight manholes were encountered along this section of pipe. No taps were found between manholes and the line ended at a 12" pipe that was bulkheaded. Inlets in the manholes appear to connect to catch basins along Seven Mile Road and to the parking areas of the businesses to the north of the storm drain. The CCTV report is included as Attachment A.

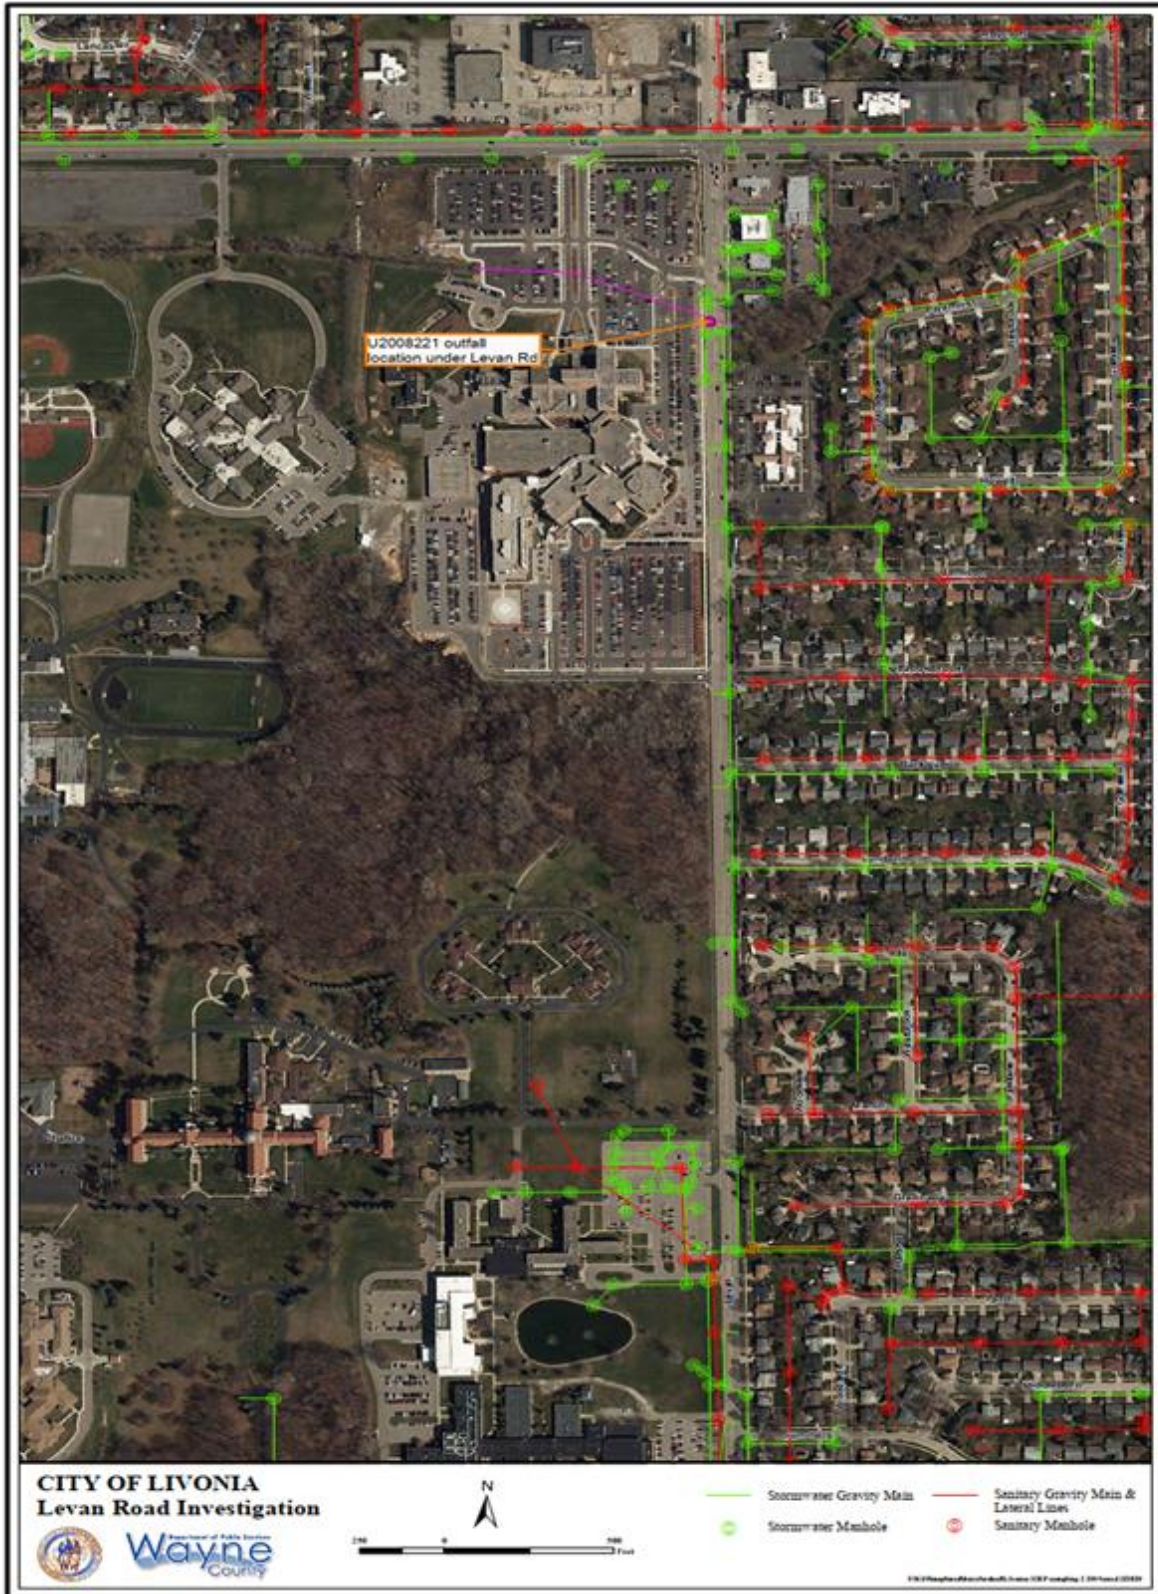
Figure 1. Storm Drain and Sampling Location

Outfall U2008221 was investigated due to the high *E. coli* concentrations found during the outfall survey conducted in 2018. At that time, the *E. coli* concentration was >24,196 MPN/100 ml which is indicative of an illicit discharge containing sanitary sewage. ARC staff reinspected the outfall in 2019 and found *E. coli* concentrations at non-detect and >6,000 MPN/100 ml respectively, with Human *Bacteroides* concentrations of 1,010,000 gene copies/100 ml coinciding with the elevated *E. coli* levels.

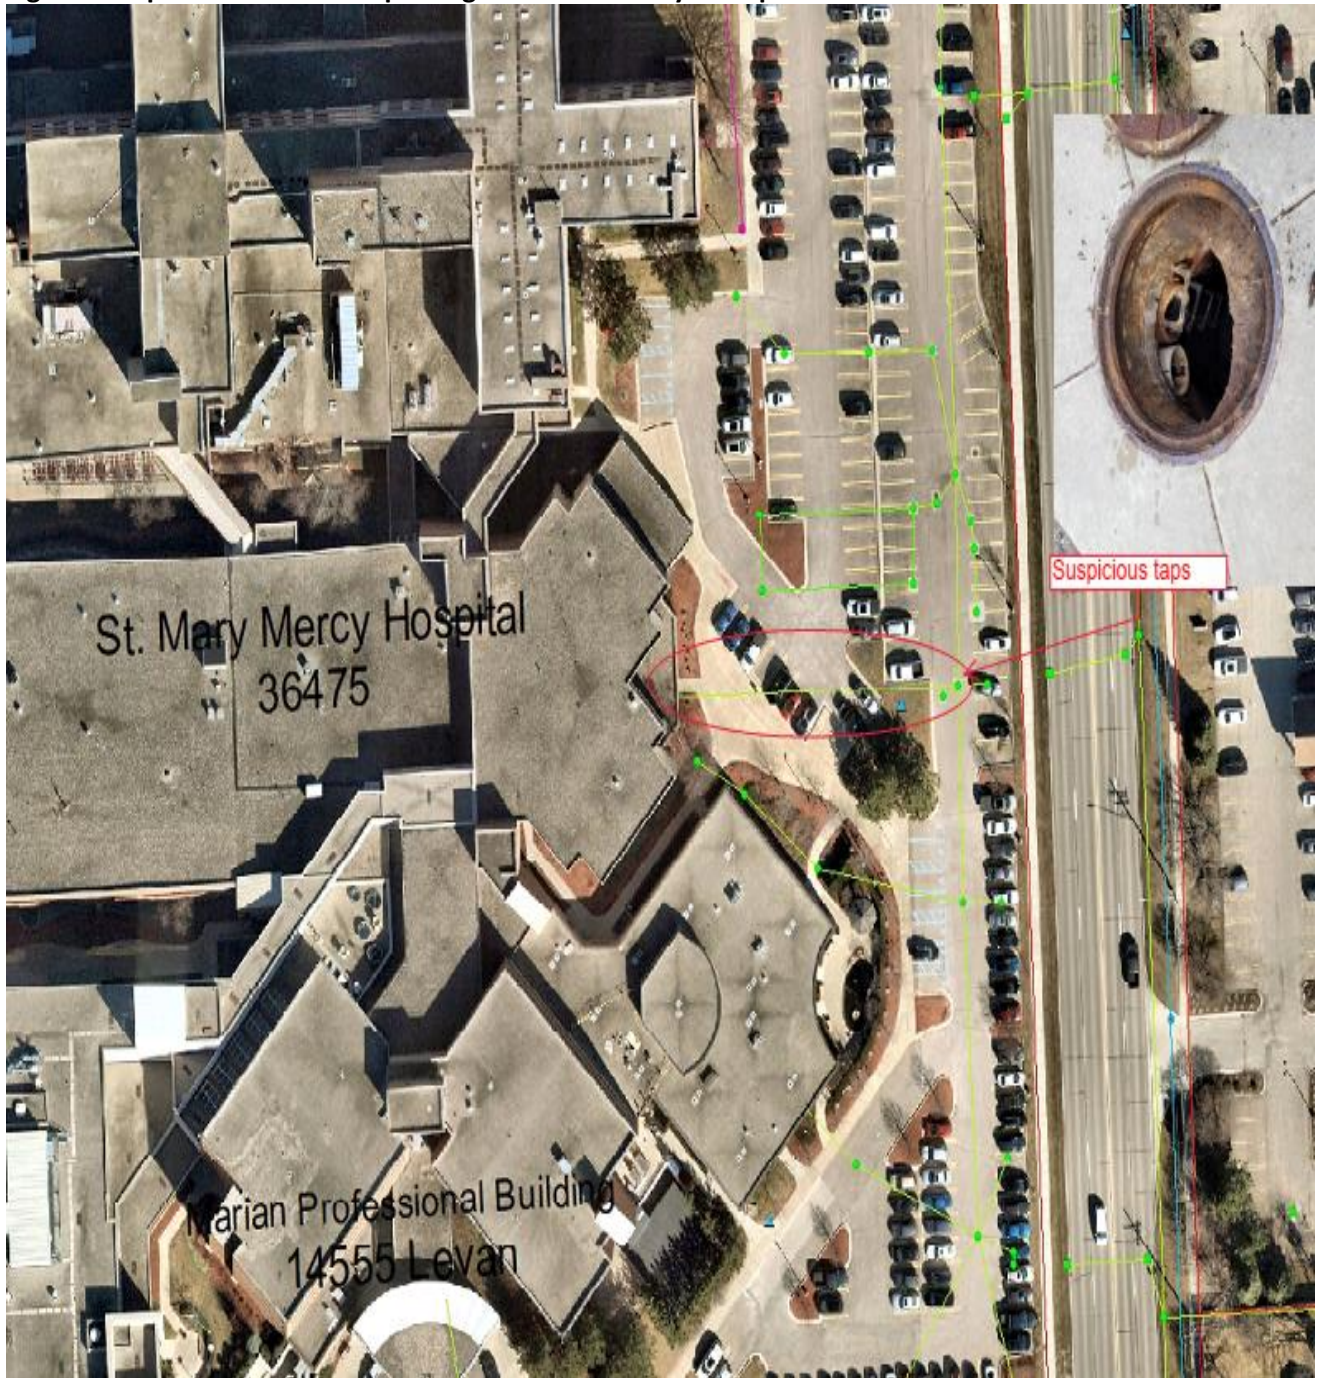
Figure 2. Tap to Storm Drain in parking lot of Saint Mary's Hospital

Inspections of manholes and review of utility drawings for the Hospital parking lot revealed a suspicious tap to the storm drain (Figure 2). Representatives from the Hospital cooperated with the City of Livonia and dye tested the area of the hospital closest to the tap. It was found that a section of the old emergency room had an illicit connection to the storm drain, which was subsequently corrected.

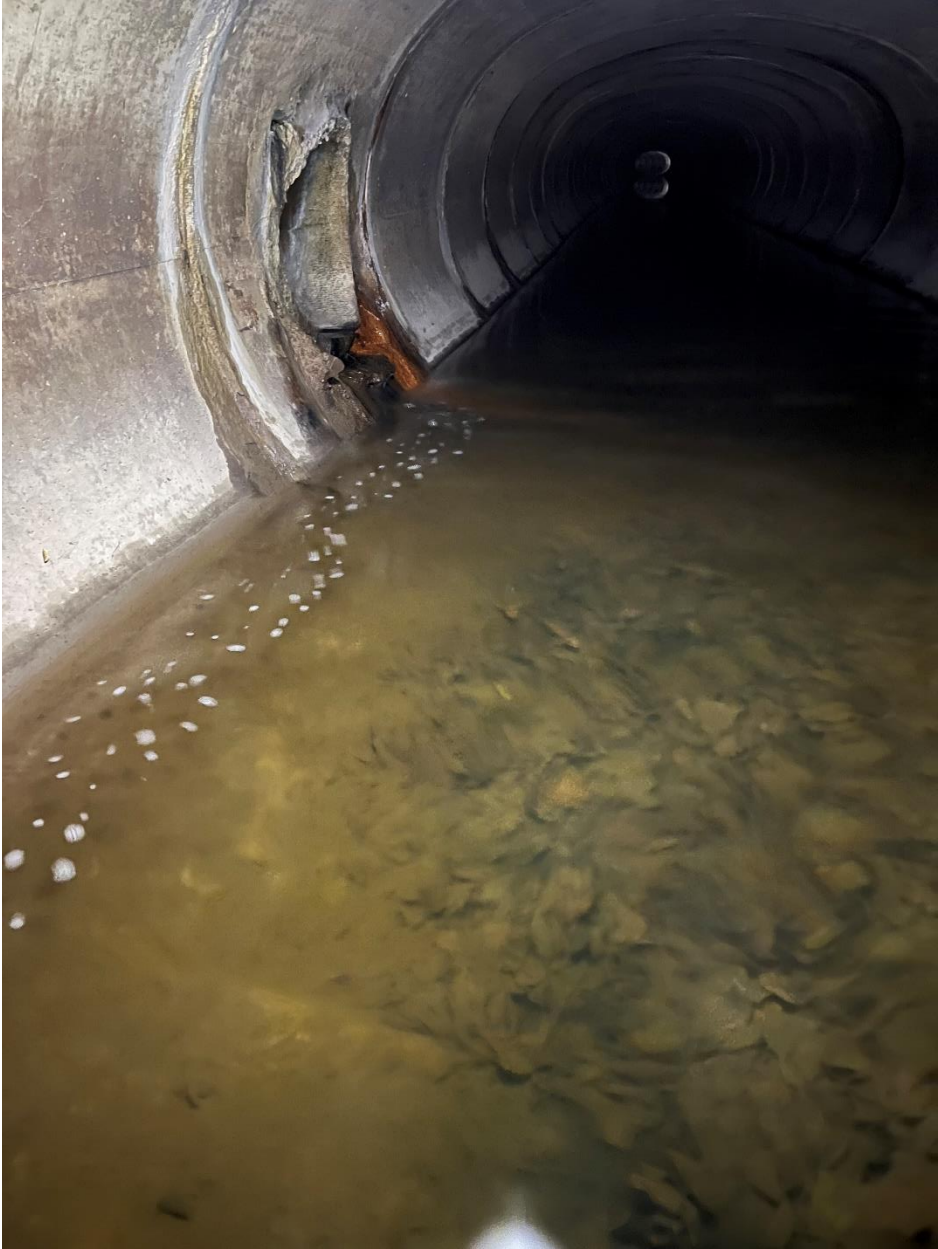
Figure 3. Bubbly water coming from the outfall

ECT resampled the outfall on November 3, 2022 to confirm that the corrected illicit connection had effectively reduced the *E. coli* levels coming from the outfall and found *E. coli* levels of 10 MPN/100 ml. However, during this sampling, bubbles that looked like soap were observed coming from the outfall (Figure 3). A test for surfactants was conducted in the field and surfactants level of 2.0 ppm was found. This indicates that although the *E. coli* source has been effectively eliminated, an additional pollutant source appears to be present that has been contributing surfactants to the river. Follow-up investigations were conducted later in November 2022. Surfactants levels of 2.0 ppm were consistently found in manholes in the hospital parking lot upstream of the outfall leading to the southern section of the parking lot. Due to a car being parked over a manhole, the investigation was not completed, and additional investigation is needed to narrow down the source of the surfactants.

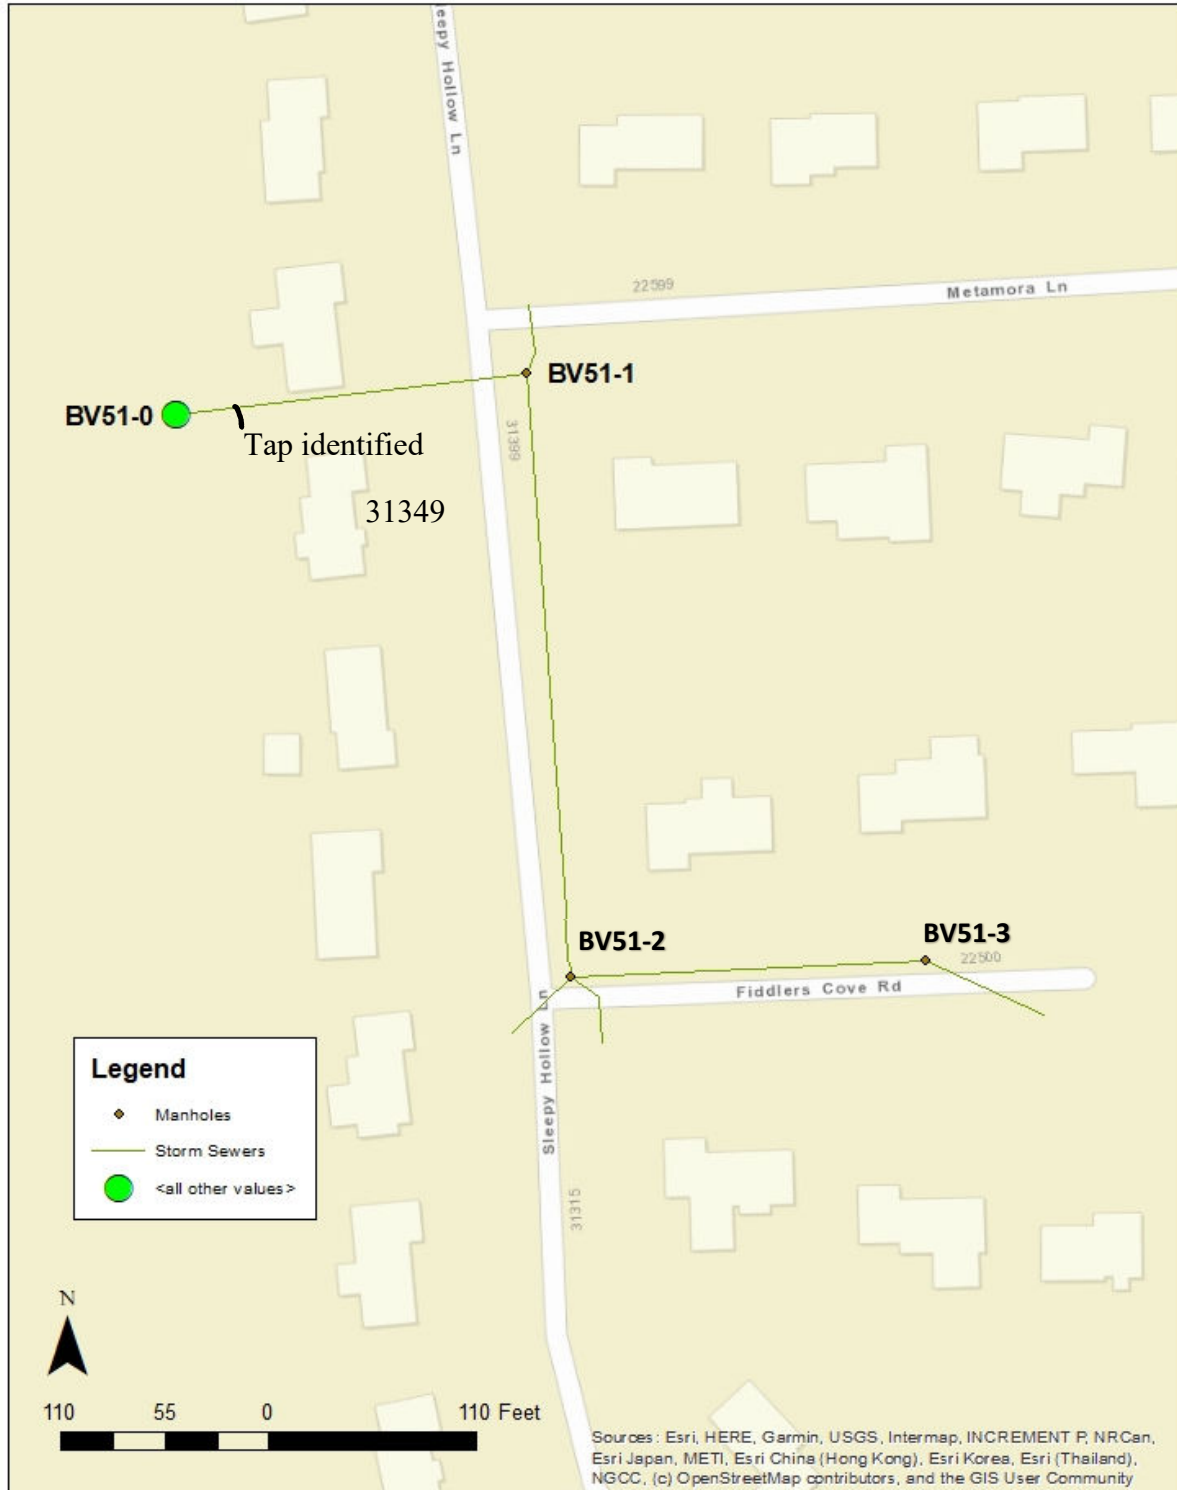
Figure 1. Storm Drain and Sampling Locations

Outfall BV51 was investigated due to the high *E. coli* concentrations found during the outfall survey conducted in 2018. At that time, the *E. coli* concentration was 3,076 MPN/100 ml which can be indicative of an illicit discharge containing sanitary sewage. ARC staff reinspected the outfall in 2019 and 2020 and found elevated *E. coli* and human *Bacteroides* concentrations (See Table 1). There were no physical signs (ex: odor, staining, debris, organic growth) of a sewage discharge to the storm drain in the outfall or any of the manholes. Likewise, there were no obvious signs of animal fecal impacts to the drain.

Work to date indicates that no illicit connection has been identified upstream of BV51. Planned work includes blocking a tap in the north side of BV51-1 to cause water to backup in a connecting catch basin and sample there. If this does not help locate an illicit connection, then dye testing additional homes in the drainage area may be necessary.

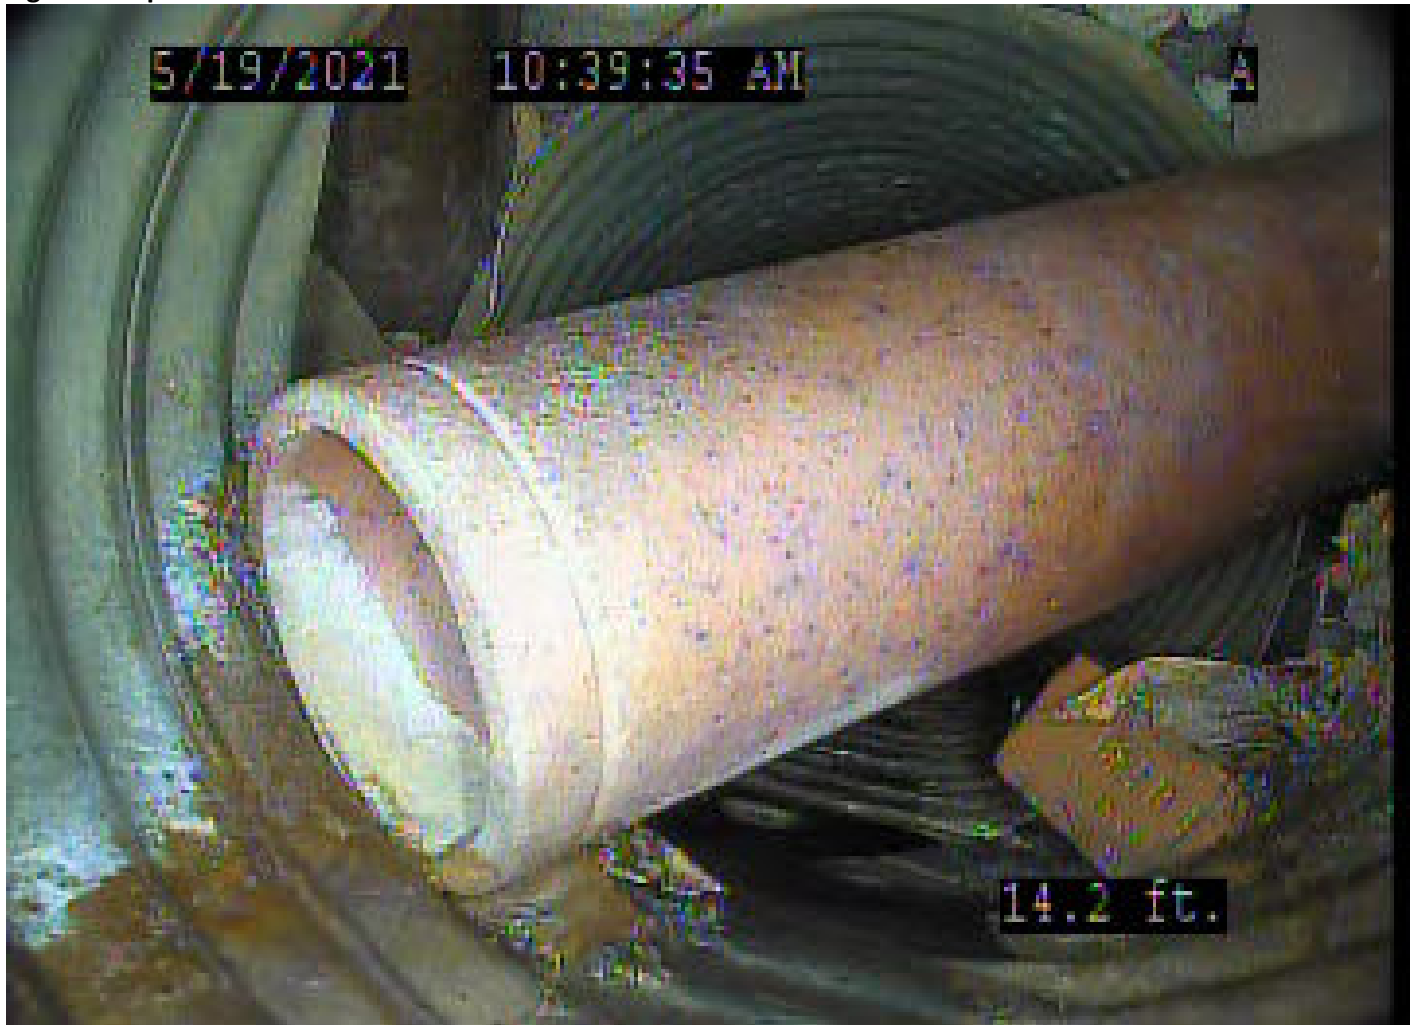
Figure 2. Tap to Storm Drain at 14.2 ft east of BV51-0

In 2021 and 2022, ARC staff coordinated with the Oakland County Water Resources Commissioner (OCWRC) to televise the drain. The drains from BV51-1 to the outfall, BV51-1 to BV51-2, and the drain from BV51-3 to BV51-2 were televised. BV51-2 is buried. A tap was identified in the storm drain between the outfall and BV51-1 that was believed to be a possible illicit connection, although no staining or evidence of sewage was observed (Figure 2).

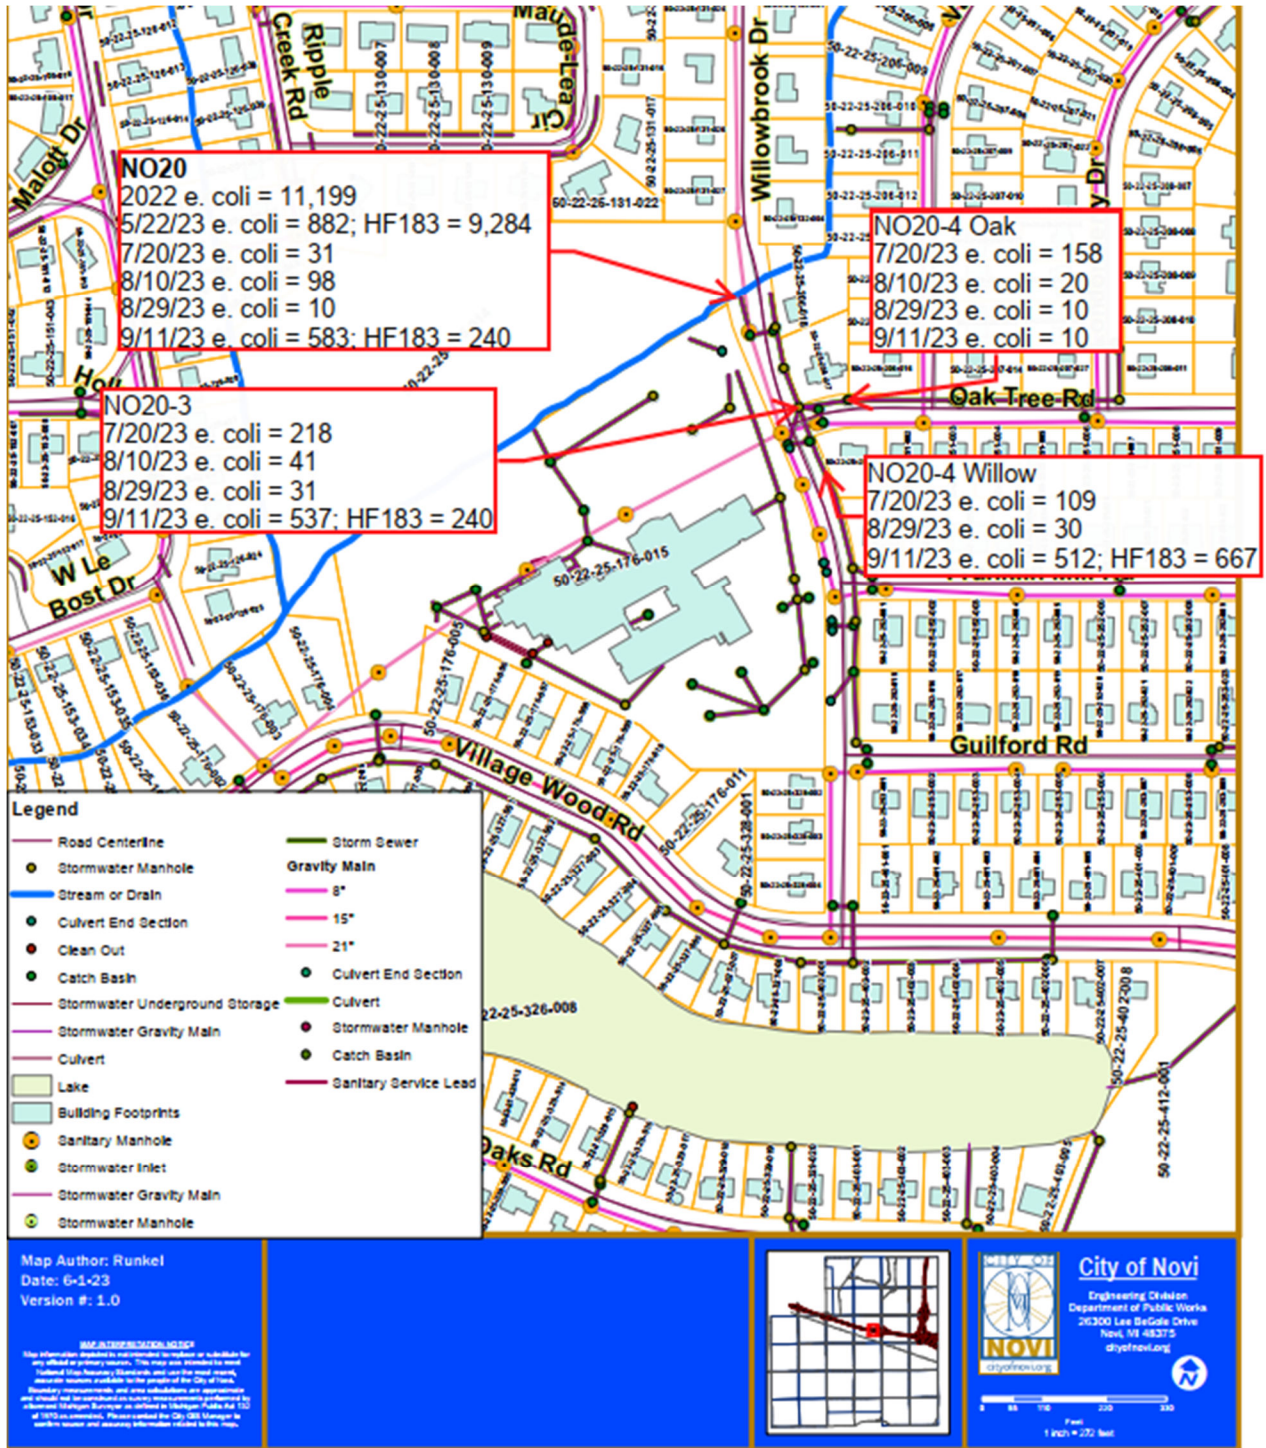
Figure 1. Storm Drain and Sampling Locations

Outfall NO20 was investigated due to high *E. coli* concentration (11,119 MPN/100 ml) found during an outfall screening conducted in 2022. There was no observed color, odor, turbidity, or other unusual characteristics noted during the initial screening.

ARC staff reinspected outfall NO20 on May 22, 2023 and found an *E. coli* concentration of 882 MPN/100 ml and human *Bacteroides* concentration of 9,284 MNP/100mL. ARC staff reinspected the outfall and collected samples from three upstream manholes to narrow down possible sources of *E. coli* contamination four more times in 2023 (Table 1). The first three sets of results had *E. coli* concentrations below 500 MNP/100mL, which indicated that testing for *Bacteroides* was not necessary and an illicit connection was unlikely. The fourth set of samples was collected incase the illicit connection was coming from the nearby school, since the first three sets of samples were collected during the summer when school was not in session. This fourth set of samples found elevated *E. coli* and *Bacteroides* at manhole NO20-4 Willow.

Due to the presence of elevated *E. coli* during the school year and not during the summer time, it is likely that there is an illicit tap coming from the school located on the west side of Willowbrook Drive. Dye testing the school and possible additional sampling is recommended as the next steps.
