Randolph Street Intercounty Drain Drainage Board Wayne and Oakland Counties

SUBJECT: Center Street Sinkhole

Re: Center Street / Randolph Drain
 Sink Hole & Discharge Pipe Investigation Report

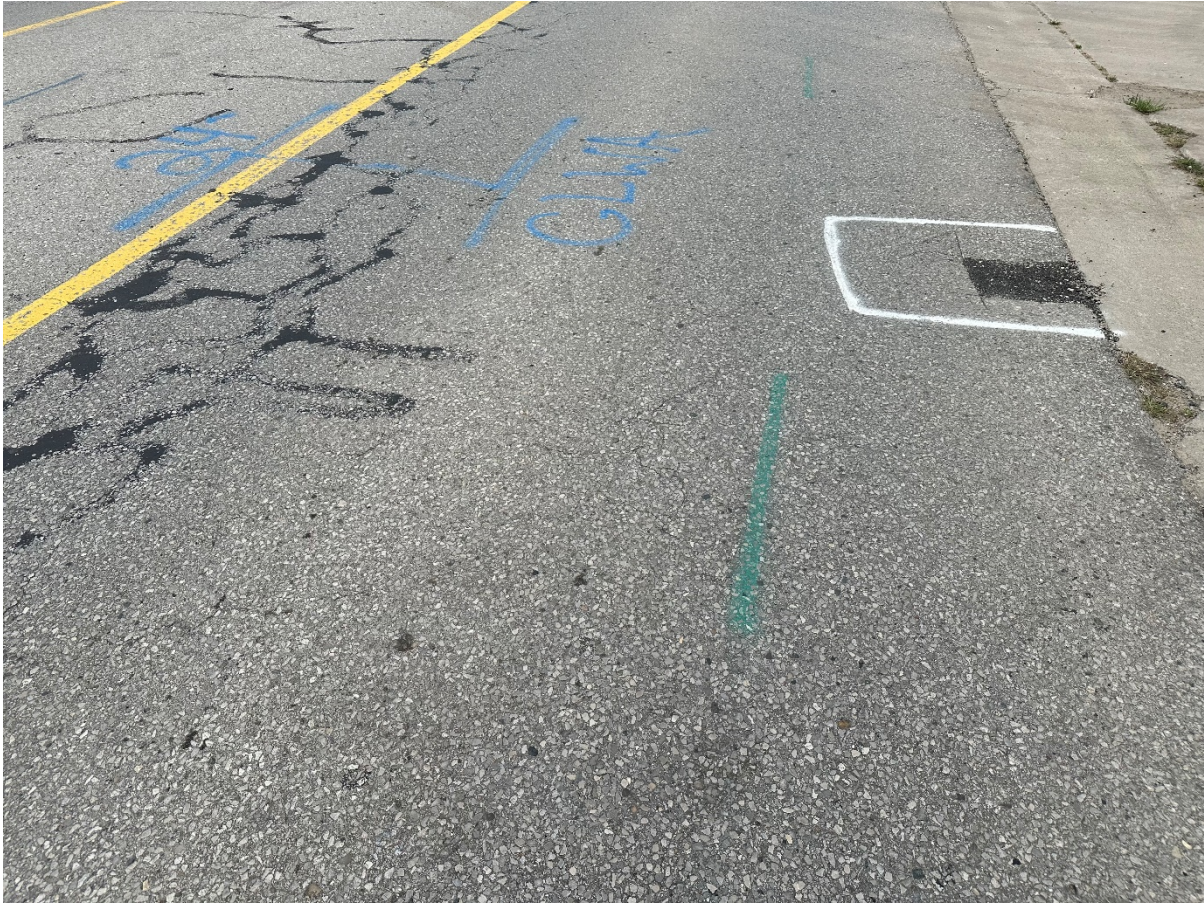
- a. Located in the north bound lane adjacent to the edge of the concrete curb. The sink hole area was filled with gravel and topped with temporary HMA road repair material.
- b. Local pavement depressions were noted in the HMA roadway at the sink hole.
- c. Several utilities were staked by MISS DIG and painted on top of the HMA roadway surface near the sink hole.
- d. Several longitudinal and random pavement cracks that had been hot poured sealed were observed.
- e. The limits of the sink hole were identified in white paint lines show in photo on page 5.

Sink Hole Looking North

The sink hole in the northbound lane is a direct result from the loss of backfill / overburden material migrating through the nominal ten-inch square void that has occurred along the inside wall of the arch brick conduit. This void is located at the interface between Segments 4 and 5 and approximately in the one o'clock position of the arched brick portion of the conduit. We understand that sinkhole was filled with granular material and later cover over with a temporary HMA repair mixture. Additional temporary repairs to the sink hole area should be implemented as soon as possible. We recommend the following:

1. Installation of a steel patch plate, shoring (pole jack or similar) and dry pack grout the void in Segment 5. "Plugging" the void should halt future backfill / overburden migration and further loss of roadway support.
2. The sink hole should first be covered with hot poured joint sealant, then immediately followed by the placement of a large road plate. The road plate would need the dimensions of about ¾" thick x 8 ft x 4 ft with the long dimension parallel to traffic. The plate will need to be anchored to the road, especially during winter months for snowplow road clearing. Hot poured joint sealant should then be applied around the edges of the plate. Diverting road run off away from the sink hole areas is important.
3. Monitor the site condition monthly, especially during the winter months.

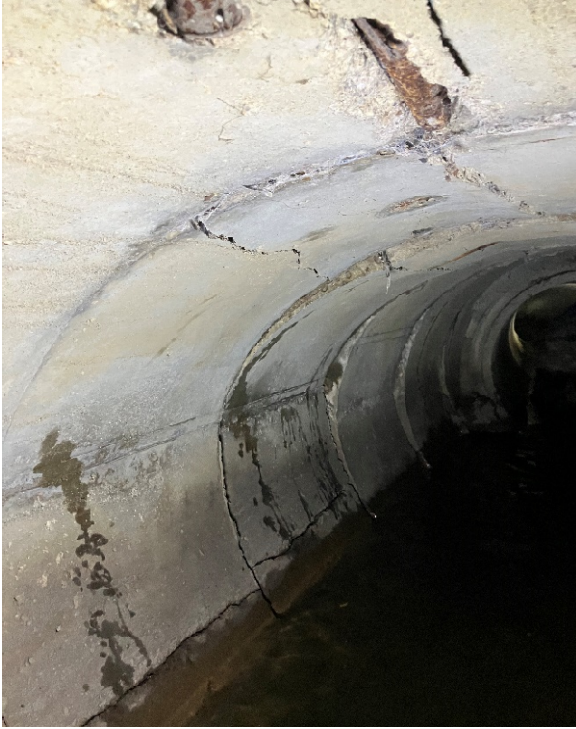
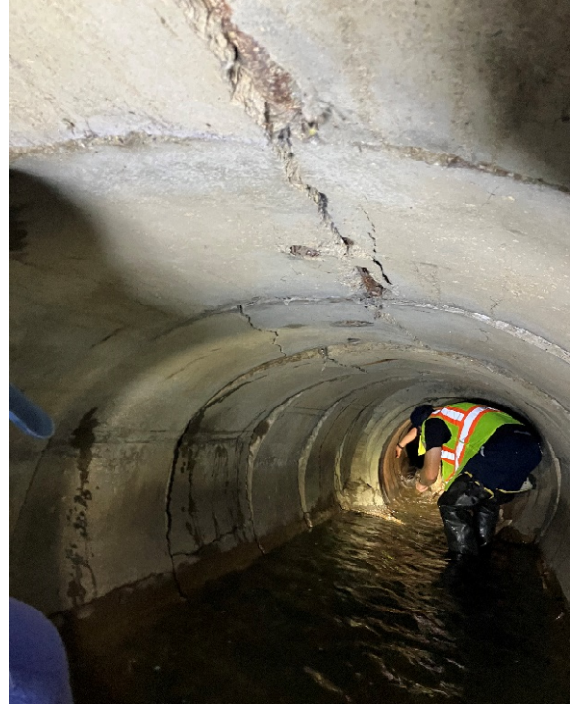
1. A considerable number of large longitudinal cracks, parallel to the pipe centerline, were found in each pipe section. These cracks were nearly evenly spaced around the pipe internal diameter. Many of the pipe sections contained six (6) to eight (8) cracks. The crack width /gap ranged from about a half to one inch with the average about three quarters of an inch. In one pipe section, a vertical differential deflection of about one quarter of an inch was observed. Cracks along the pipe invert were typically noted with about three inches of stream flowing over and along these cracks. Concrete steel reinforcement was not observed in this pipe segment.

Longitudinal Pipe Cracks

Segment 2 consists of cracked and severed non reinforced concrete pipe. Six to eight transverse (parallel to flow) large cracks were observed in each pipe section and individual pipe sections have resulted. The pipe no longer has the structural integrity necessary to support the loads above. We recommend the following:

1. Install temporary shoring throughout the 53 ft length of this section. Shoring may consist of two sets of pole jacks supporting 6" x 6" wood header beams, top and bottom. One set would be in the vertical plane and another in the horizontal plane. Each set would need to be laterally restraint either by friction or small mechanical connections.
2. Monitor the site condition monthly, especially during the winter months.

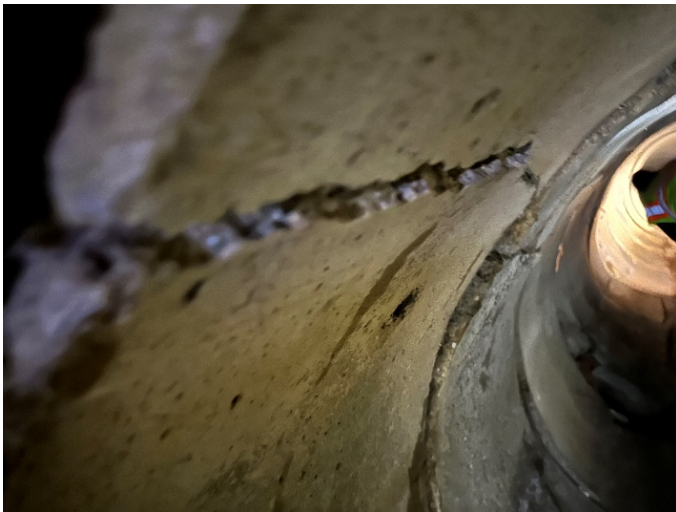
3. **Overall** – Segment 2 can be classified as in serious to critical condition. Temporary or permanent repairs should be installed to shore the individual pipe sections from collapsing.

Severed Pipe Sections

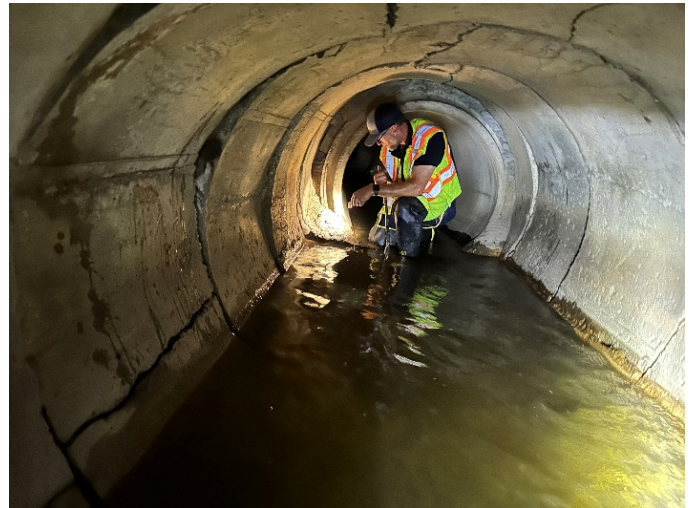
Cracked and Deteriorated Sections

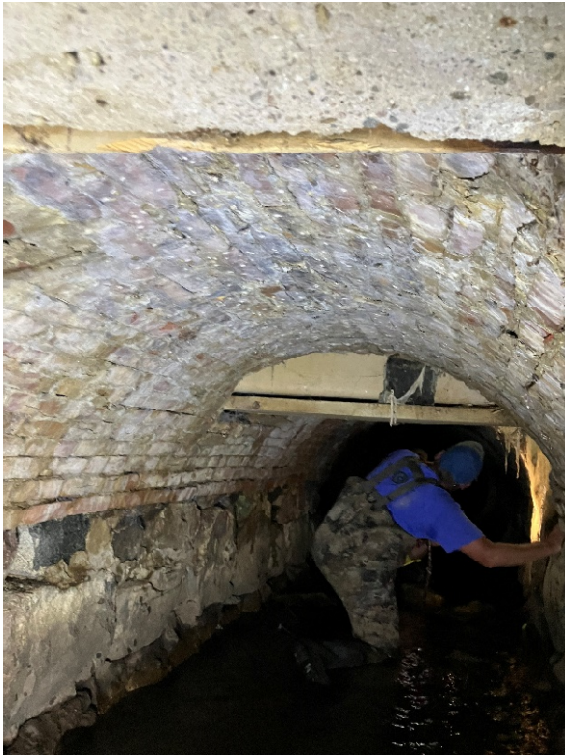
1. The construction consisted of the bottom 1.5 feet of mortared rock and cobbled stone that supports a brick arched conduit. This type of construction was common during the late 1800's / early 1900's.
2. At a number of locations, the mortar between the bricks is cracked and missing. Several loose bricks were noted.
3. At a few locations, cracks through the bricks were also observed.
4. Large continuous wall erosion due to the stream has occurred along the bottom support for the brick walls.
5. Large cobble stones noted on the bottom of pipe in the areas of wall erosion.
6. The surrounding backfill was observed migrating through the loss of mortar voids.
7. At the western end of Segment 5, a large void with dimensions of about 10" x 10" x 8" was observed. This void was located near the bottom of the arch where it meets the vertical wall. The overburden material in this area is

Loss of Mortar Support

13. **Overall** - Segment 5 can be classified as Poor to Serious. Temporary repairs should be installed immediately to shore and fill the sink hole area. A more permanent solution should be implemented within the next year.

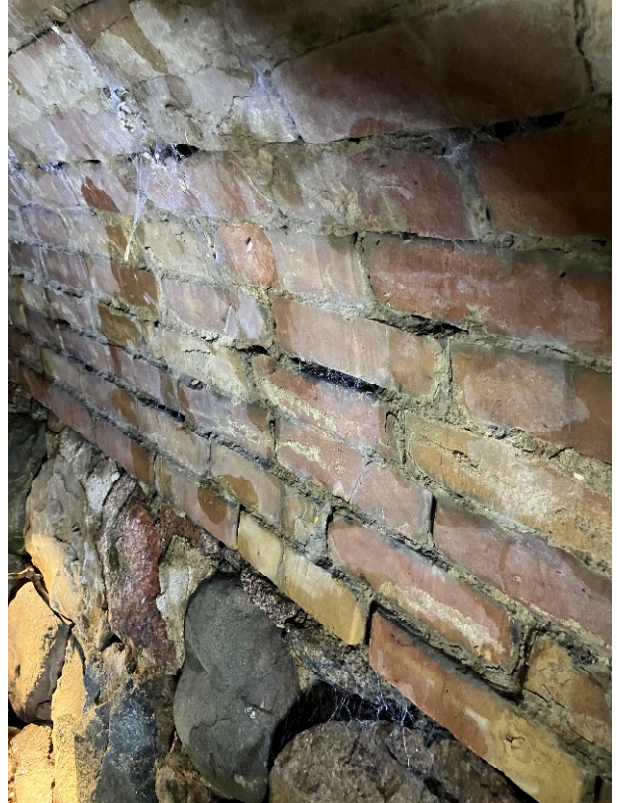
10. Settlement type cracks were observed in the brick wall portions of the arch.
11. At the transition between Segments 5 and 6, voids behind the brick arch were noted.

Cracks Within the Brick Arch

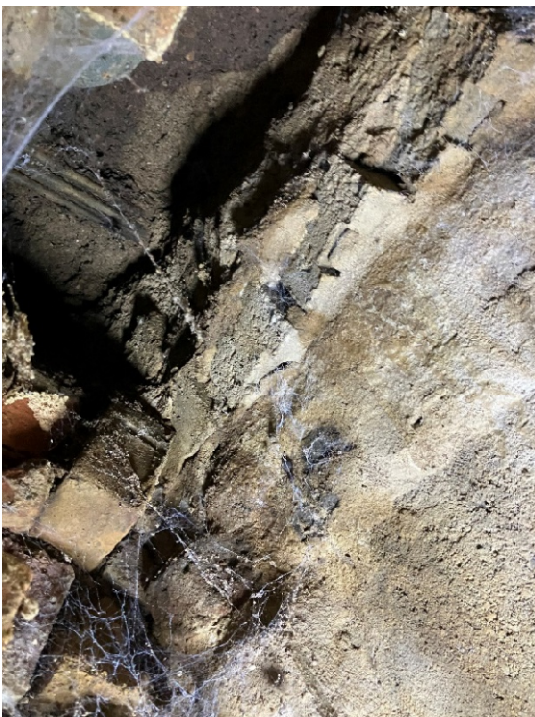
missing and the remaining in place overburden material is moist to wet. This void is located nearly directly below the roadway sink hole in the northbound lane.

Void in Brick Arch (Looking up)

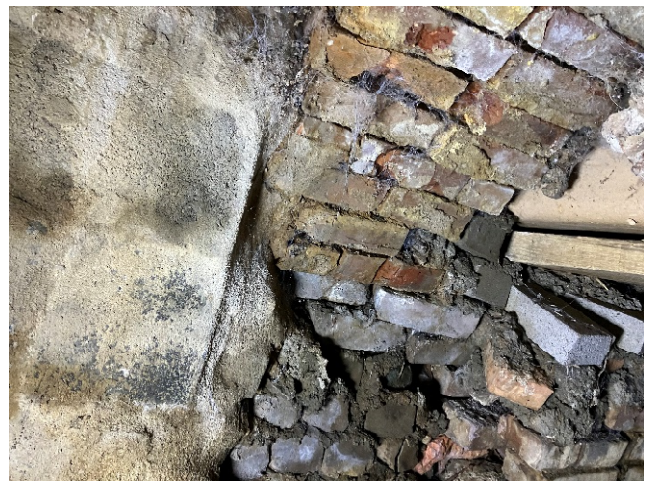
Loss of wall Arch Support

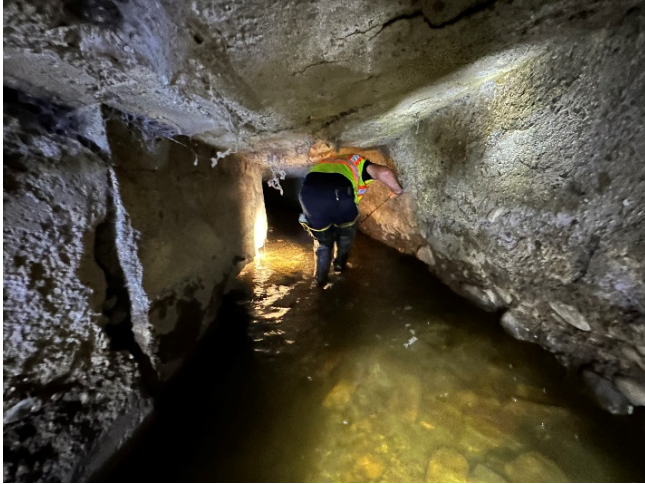
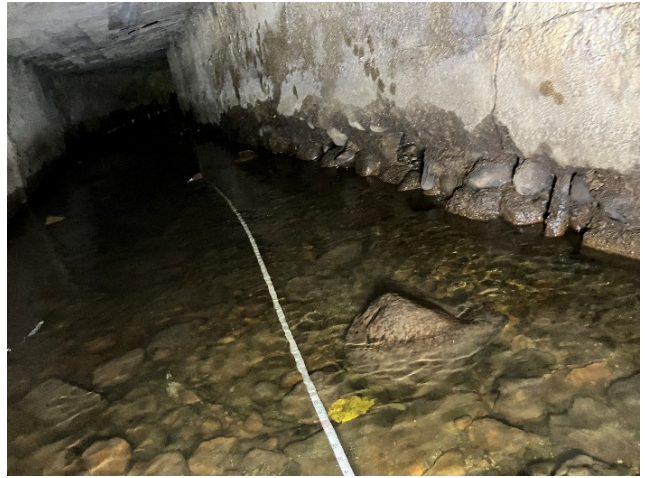
3. Large continuous wall erosion due to the stream has occurred along the bottom of the cast in place walls at streambed elevation. This erosion has undermined a significant length of Segment 6 along both walls.

4. A significant volume of wall concrete has been removed at the outside interior bend of the conduit.
5. Large cobble stones and backfill were noted in these erosion areas.

Significant Wall Erosion

10. A copper utility conduit is crossing through the walls, near the outfall.
11. **Overall** - Segment 5 can be classified as Poor. Repairs should be completed for longevity enhancement within the next 1-2 years.

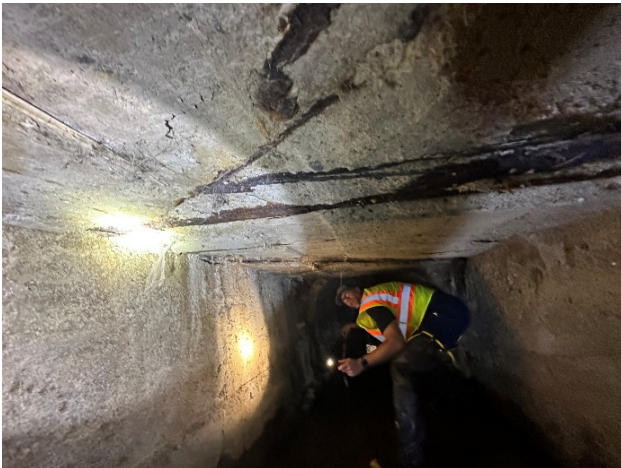
1. Concrete placement form lines were visible. Construction was likely during the early 1900's.
2. Several large areas of delamination, significant amount of honeycombing, scaling, efflorescence, and spalls noted along the top slab underside.

8. Numerous cracks within the walls and underside of the top slab were observed throughout the length of Segment 6.
9. Exposed deteriorating square steel reinforcement along the underside of the slab was observed.

Significant Top Slab Deterioration

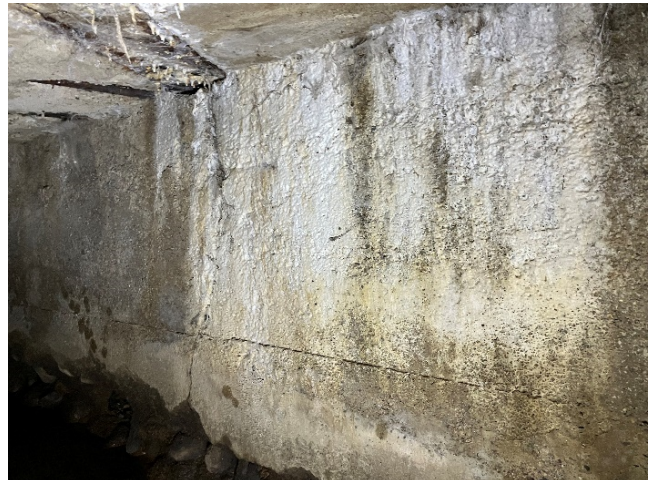
Top Slab Efflorescence
